# **Performance Evaluation of the Scrayingham Waste Stabilization Pond System, North Yorkshire**

Fourth Year Stage II Project Dissertation  
Submitted in Partial Fulfilment of the Requirements for the Degree of  
Master of Engineering (MEng) in Civil & Environmental Engineering.

School of Civil Engineering  
University of Leeds  
**August 2006**

*Note: this pdf file contains only Chapters 6-9 of Martin Long's dissertation which relate directly to the Scrayingham ponds.*

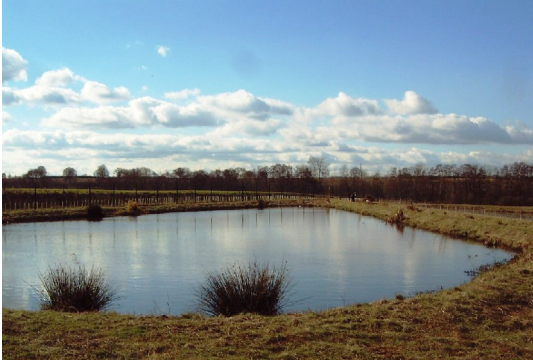
Figure 6.2 Facultative pond

The facultative pond, shown in Figure 6.2, has a maximum depth of 1.5 m and a surface area of 1443 m<sup>2</sup>. Taking account of the slope of the embankment, the pond has an estimated volume of 1731 m<sup>3</sup>. At a predicted average flow of 42 m<sup>3</sup>/day the pond has a HRT time of 41 days. The effluent is filtered through a 100-mm rock filter 4 m in length (Figure 6.3). This filter is planted with substantial amounts of true bull rush (*Scirpus lacustria*) to maintain hydraulic pathways and help maintain aerobic conditions. The effluent exits the pond through a V-notch weir (Figure 6.4), which regulates the flow to the rest of the system during periods of high rainfall.

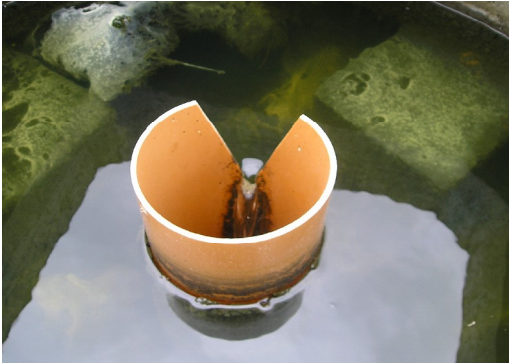
Figure 6.4 V-notch weir

m<sup>3</sup>. At the predicted average flow of 42 m<sup>3</sup>/day it takes 0.8 days for the water to pass through each of the five ponds, giving a total retention time of 4 days for the maturation ponds. The water exits the fifth pond via a V-notch weir similar to that of the facultative pond (Figure 6.4).

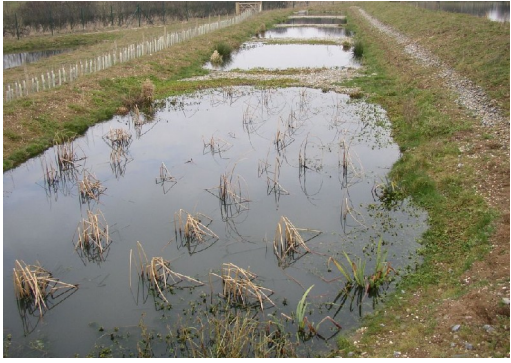
Figure 6.5 Maturation ponds

Once the wastewater has exited the facultative pond it passes through the series of five maturation ponds shown in Figure 6.5. The liquid enters the first pond below the water surface and flows through five ponds of equal size. Each pond is separated by a 3-m length of rock filter consisting of 40-mm gravel to prevent algae being washed out of the system.

The five maturation ponds each have a maximum depth of 0.5 m and a surface area of 87 m<sup>2</sup>. Taking account of the slope of the embankment, the ponds have an estimated volume of 34

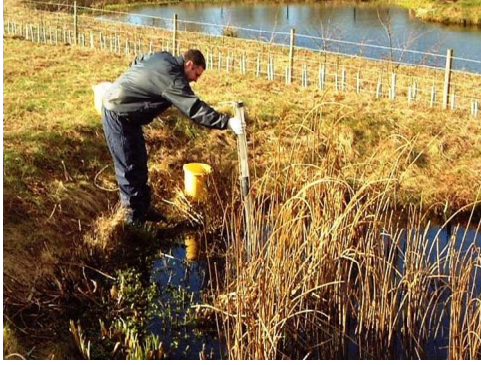
**Figure 7.2 Taking a column sampling**

Attempts were made to collect column samples from each of the ponds as shown in Figure 7.2. However, the large amount of plant life within the ponds combined with the shallow depth of the maturation ponds (approximately 40 cm), and the shallow gradient of the facultative pond embankment (Figure 7.3) made it impossible to collect column samples from the pond's edge without contaminating them with sediment (Figure 7.4). Consequently grab samples were taken from the top 30 cm of the ponds using a 35-cm diameter bucket as shown in Figure 7.5.

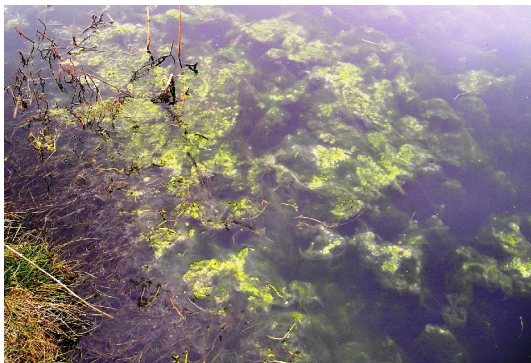
**Figure 8.1 Filamentous algal bloom**

It was noted that after the prolonged wet conditions between 15 March and 5 April, the level of the River Derwent rose until it was no longer within its natural channel. This seemed to coincide with a bloom of filamentous algae occurring in the final maturation pond (Figure 8.1). At its peak on 5 April, the algae were so dense that the pond surface was almost entirely occupied by floating mats of algae. The bloom never occurred on the surface of any other pond, although there was evidence of material growing below the surface of the other maturation ponds (Figure 8.2). When samples were collected from these ponds, great care was taken to avoid the filamentous algae and vegetation, and to collect only the liquid.

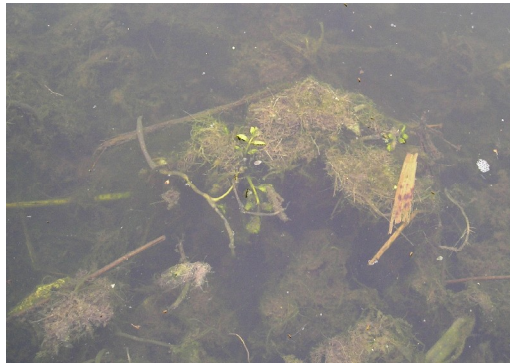
**Figure 8.2 Vegetation at the base of the maturation ponds**

Birds were observed on the ponds from 8 March onwards. By the beginning of April, many plants began to emerge around the pond embankments, and the true bull rush began to grow in the facultative pond rock filter. By 12 June the site and embankments were overgrown.

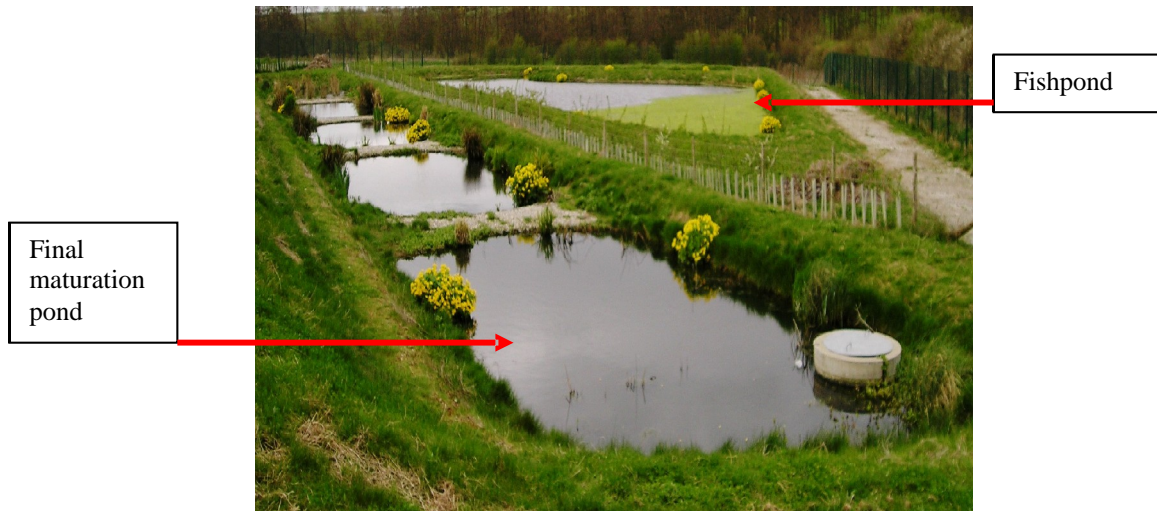
**Figure 8.3 Fishpond Algal Bloom**

Although the algal bloom did not occur in the other waste stabilization ponds, it did occur in the fishpond, which the final maturation pond discharges into (Figure 8.3). The bloom remained in the fishpond after it had disappeared from the final maturation pond and was still there after this study was completed on 26 April. Arthur (1983) states that filamentous algae can occur in pond systems which are underloaded.

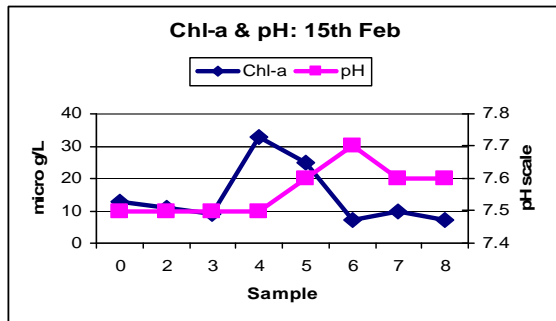
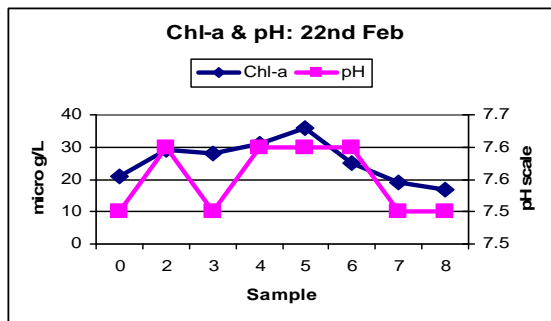
Figure 8.6 Chlorophyll a vs. pH

A comparison of chlorophyll *a*, pH and suspended solids is displayed in Table 8.5. A graphical representation of the relationship between chlorophyll *a* and pH can be seen in Figure 8.6, and the relationship between chlorophyll-*a* and suspended solids in Figure 8.7.

Figure 8.6 shows an apparent relationship between pH and chlorophyll *a*. The two sets of data were correlated to give an R value of 0.84. This shows that there is a good relationship between pH and chlorophyll *a*. Looking at Table 8.5 it appears that when there is little or no algae in the sample the natural pH of the liquid is around 7.4–7.5. The maximum pH value recorded was 8.8 on 15 March in the facultative pond when the concentration of chlorophyll *a* was 500 µg/L. A pH value of 8.8 was also recorded on 5 April when the pond had a

chlorophyll *a* concentration of just 350 µg/L. However, on this day the weather was clear and it is likely that a significant proportion of the algae were at a depth beyond where the sample was taken from.

The pH values found in the ponds on 29 March seem high, but this was a clear day when a significant proportion of algae may not have been contained within the facultative pond sample. The pH values for the ponds may be higher when a surface grab sample is taken than if a column sample had been taken. This is because of the different rates of algal photosynthesis occurring at different depths of the pond, causing a vertical variation in pH (Konig *et al.*, 1987). In a column sample these different values would be mixed together to give an average. As the majority of algal photosynthesis occurs towards the top of the pond it is likely that the pH values found in surface grab samples should be larger than those expected from a column sample.

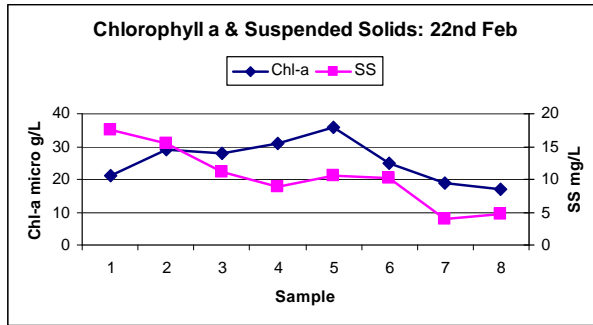
Figure 8.7 Chlorophyll a vs. Suspended Solids

From viewing Figure 8.7 it appears that the concentration of suspended solids change when the concentration of chlorophyll *a* changes. Correlating the two sets of data gave an R value of 0.82. A correlation of 0.82 indicates that there is a good relationship between the concentration of chlorophyll *a* and suspended solids in top 30 cm of each pond. This implies that the majority of the suspended solids which leave in the final effluent are algal solids, and not the more harmful BOD solids.

The concentration of suspended solids in the final effluent never failed the EA's discharge consent of 60 mg/L. The solids concentration in the final effluent was always <10 mg/L, apart from on 8 and 15 March shortly after the filamentous algal bloom began establishing itself. On these two occasions the concentration of chlorophyll *a* was higher in the effluent discharge than it was at the entrance to the final maturation pond. It is possible that these higher suspended solids concentrations of 31 mg/L and 19 mg/L are due to filamentous algae being washed out of the pond.

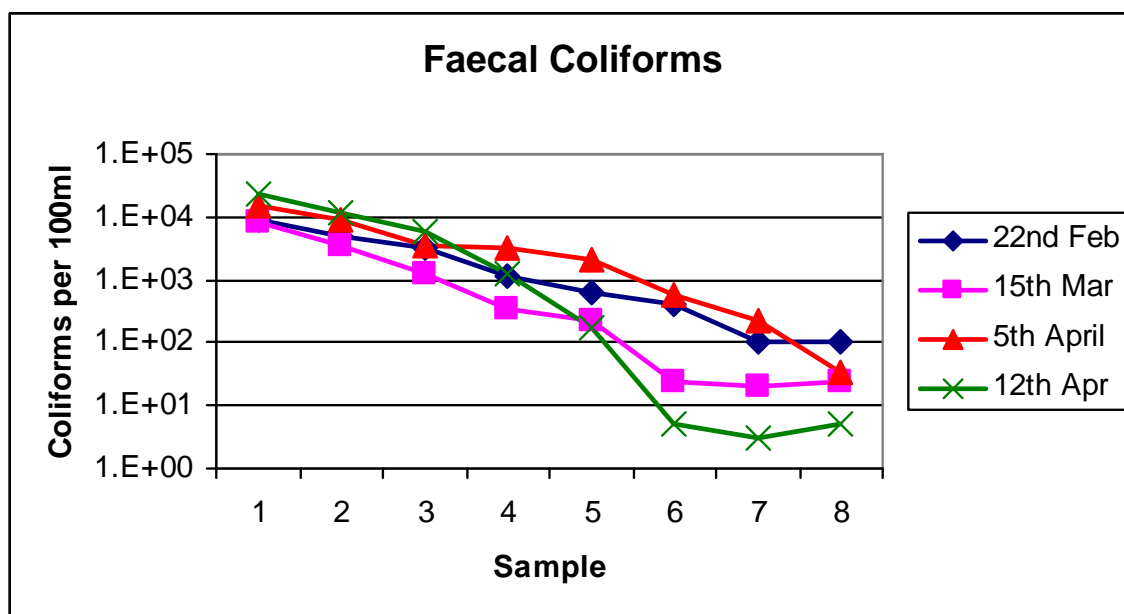
**Figure 8.8 Faecal Coliform Removal**

From Table 8.7 it can be seen that the facultative pond reduces the number of FCs by an average of 48%. By the time the effluent reaches the inlet to the 3rd maturation pond, the average FC count is <1000 per 100 ml. Only on 5 April was the number of colonies higher, but even then the number was reduced <1000 per 100 ml once the effluent reached the inlet to the 4th maturation pond.

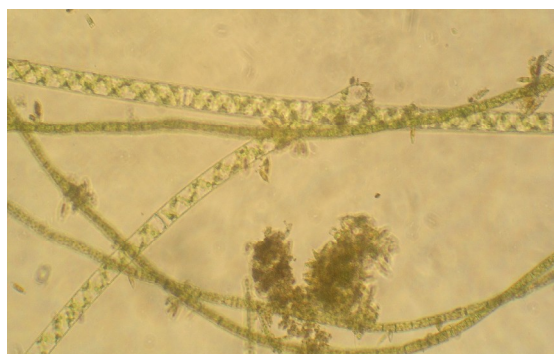
**Figure 8.10** *Spirogyra*

The increased levels of ammonia at the beginning of the study period caused a filamentous algal bloom to occur in the final maturation pond. Microscopic analysis of the algae revealed the presence of *Spirogyra* (Figure 8.10).

*Spirogyra* forms dense, bright green mats in shallow slow-moving waters. It is found in nutrient-rich waters (Bellinger, 1992; Microscopy UK, 2006), and its presence in large amounts can indicate excess phosphorus and nitrate from fertilization of farmland (Microscopy UK, 2006). These excess nutrients can contaminate storm-water run-off, which finds its way into the sewer network via surface drains.
