3. EXPERIMENTAL FULL SCALE SYSTEMS

3.1. Introduction

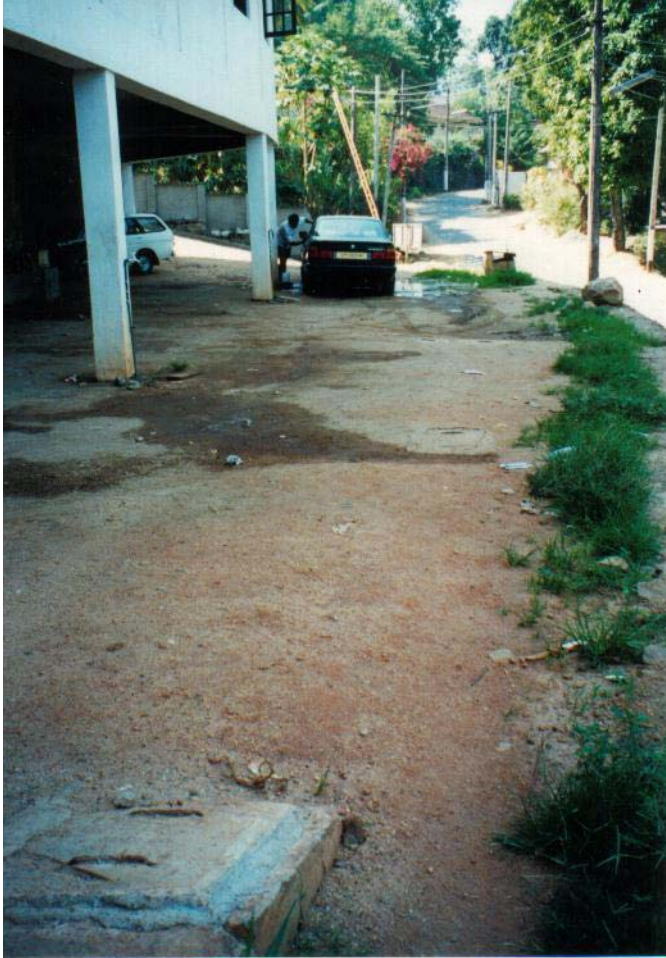
Plate 3-2. Service access to the Swiss Residence under which system 1 units are located, with treated effluent being used for vehicle washing

Plate 3-2 shows a view of the service access drive under which the units are located, with the treated effluent being used for vehicle washing. The access manhole to the first stage of the anaerobic filter is visible in the foreground at the bottom right of the picture, and that of the second stage is visible in the centre of the picture. The building to the left, houses drivers' quarters and a restaurant. The suburban street on which the hotel is located is visible in the background of the picture.

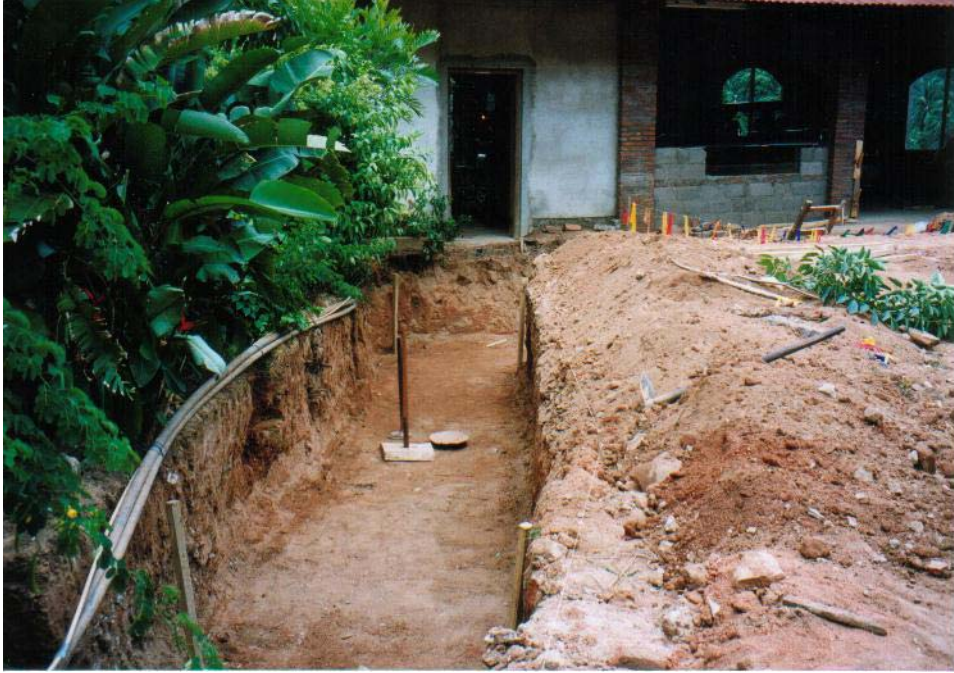
Plate 3-3. Excavation for the VFPGF unit for system 2 during construction stage.

System 2 comprised a grease trap followed by a septic tank and VFPGF unit. The grease trap and septic tank were both in brick masonry and the septic tank was designed for a five-year sludge storage capacity. The VFPGF had an effective depth of 0.6 metres and a design specific area of $0.4 \text{ m}^2/\text{p.e.}$. The septic tank was buried under a corner of the parking lot. The VFPGF was located at the edge of the parking lot and was designed in an 'L' shape to fit into a corner. The treated effluent was discharged to the storm drain running alongside the main entrance driveway of the hotel. Plate 3-3 shows the 'L' shaped excavation for the VFPGF unit during construction, and Plate 3-4 shows the unit after commissioning.

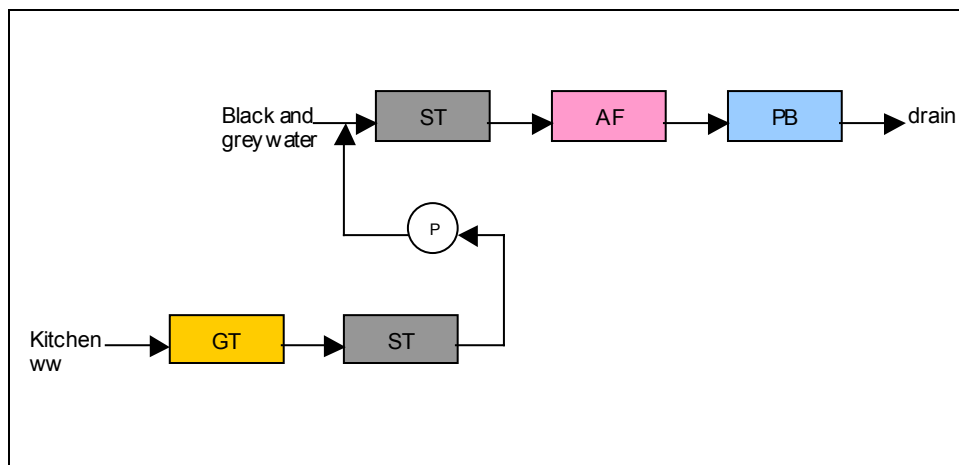
Figure 3-3. Process flow diagram of Devon Hotel treatment system

All the units other than the percolation bed were constructed in reinforced concrete. The main septic tank comprised two units cast together in parallel, and the anaerobic filter comprised four parallel units cast on either side of a central distribution chamber. The septic tanks were designed for a five-year sludge storage capacity and a hydraulic retention time of 1.5 days. The anaerobic filter was designed for a nominal HRT of 1.5 days. The percolation bed had a design specific area of 1.5 m²/p.e. and an effective bed depth of 1 metre. The bed was laid in a combination of metal chips and gravel. Draft tubes were provided for passive ventilation. Plate 3-5 and Plate 3-6 show views of the hotel building and entrance forecourt area under which the main septic tanks, anaerobic filters and percolation bed are located. The access manholes to the septic tanks are located by the service door at the far corner of the forecourt in Plate 3-5. The distribution chamber of the anaerobic filter units is located under the central landscape feature. The access manhole is open in Plate 3-6, and the cover can be seen behind the potted palm in the foreground of the picture. Plate 3-7 shows the percolation bed being laid during the construction phase. The dark material at the corner of the bed is metal being laid in a reverse filter arrangement around the effluent collector pipe.

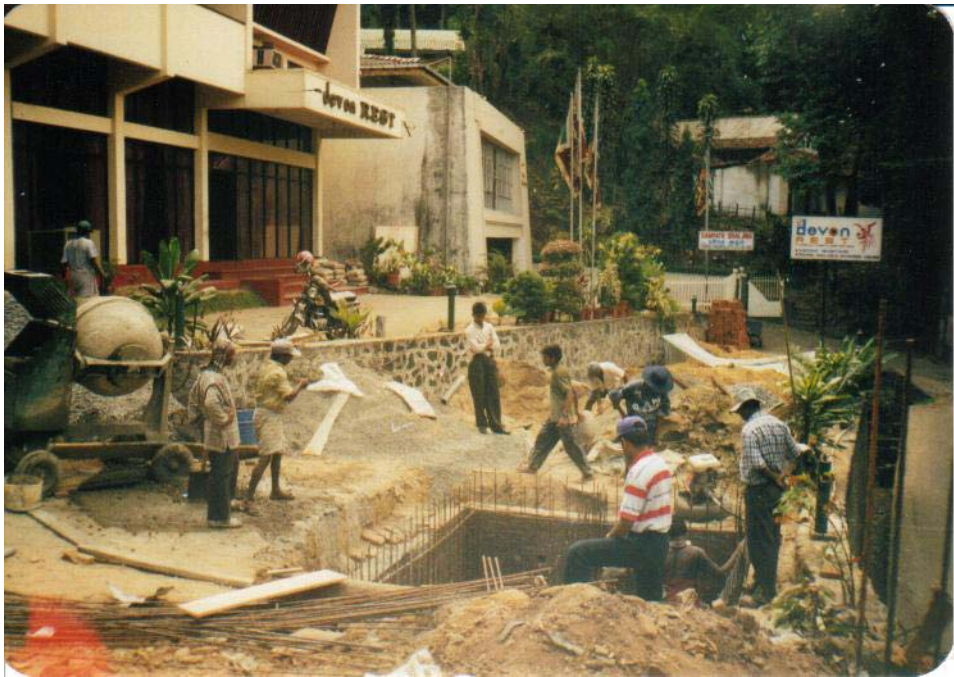
Plate 3-8. Hotel entrance and driveway during construction of the anaerobic filter unit.

Plate 3-8 shows the hotel entrance and driveway during construction of the anaerobic filter unit. The septic tank is located under the upper part of the driveway, between the main entrance and the rubble masonry retaining wall visible in the middle of the picture. The percolation bed is located on the lower part of the driveway, at the toe of the retaining wall, beyond the anaerobic filter unit.

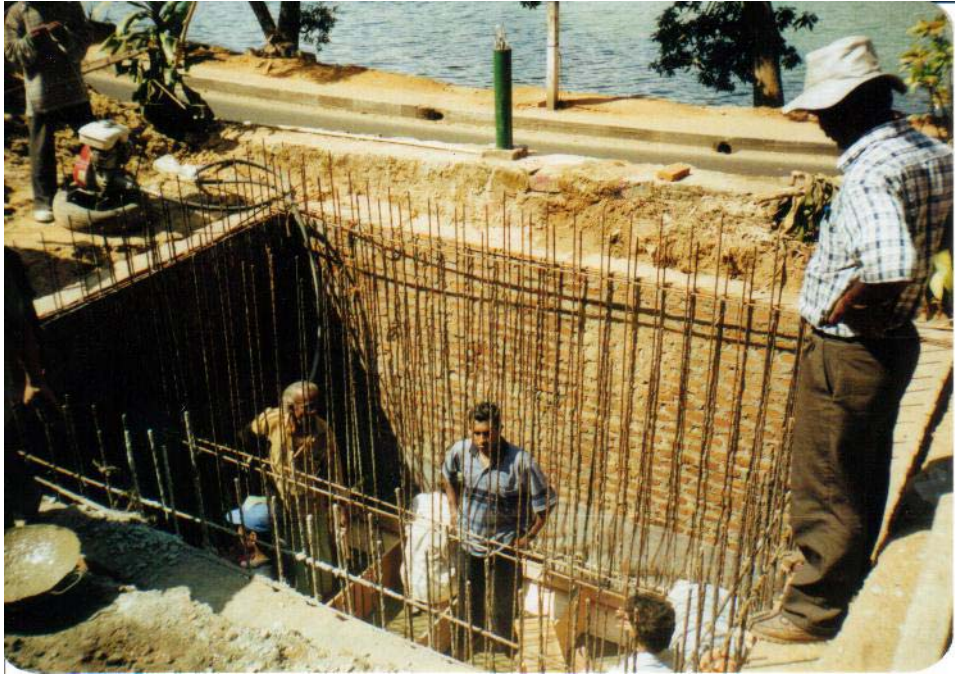
Plate 3-9. The anaerobic filter unit during construction.

Plate 3-9 shows a view of the anaerobic filter unit under construction. The Kandy Lake is visible in the background. Plate 3-10 shows the driveway after construction was completed.

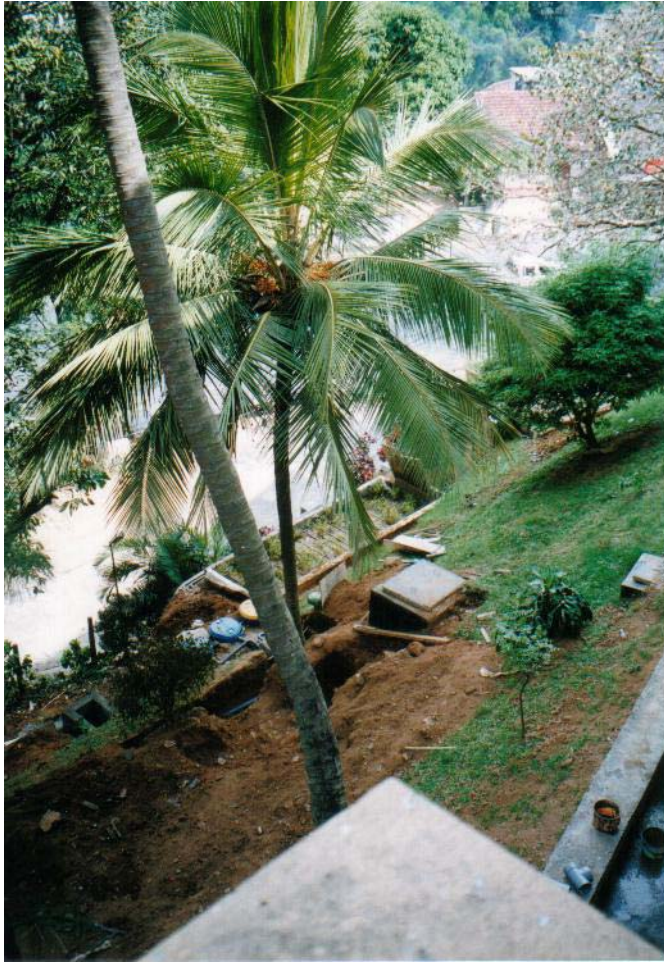
Plate 3-11. Steep terrain behind office block where VFPGF units of System 1 were located.

Plate 3-11 shows a view of the steeply sloping terrain behind the office block where the VFPGF units were located. This kind of steep slope was typical for the property. Plate 3-12 shows a view of the site where the lower VFPGF unit was located, prior to implementation of the project. As can be seen in the photograph, the site abuts a suburban street. Plate 3-13 shows an aerial view of the same site, with the VFPGF unit in place, prior to planting of vegetation. The influent distributor laterals are visible, lying on the surface of the bed. The three parallel units of the VFPGF were separated by HDPE liners, with separate influent distributors for each unit. Plate 3-14 shows a view of the same unit after commissioning and establishment of vegetation. Plate 3-15 shows the second VFPGF during construction. The two parallel units are visible at the top right and centre left of the picture. At the lower left hand corner of the picture, the flow splitter box and dosing siphons to the three parallel units of the lower VFPGF are visible. Plate 3-16 shows the combined septic tank – anaerobic filter during construction under a parking area. Plate 3-17 shows the same area immediately after completion of construction. The access manholes to the units are visible in the picture. Plate 3-18 shows the treated effluent from System 1 being reused for gardening.

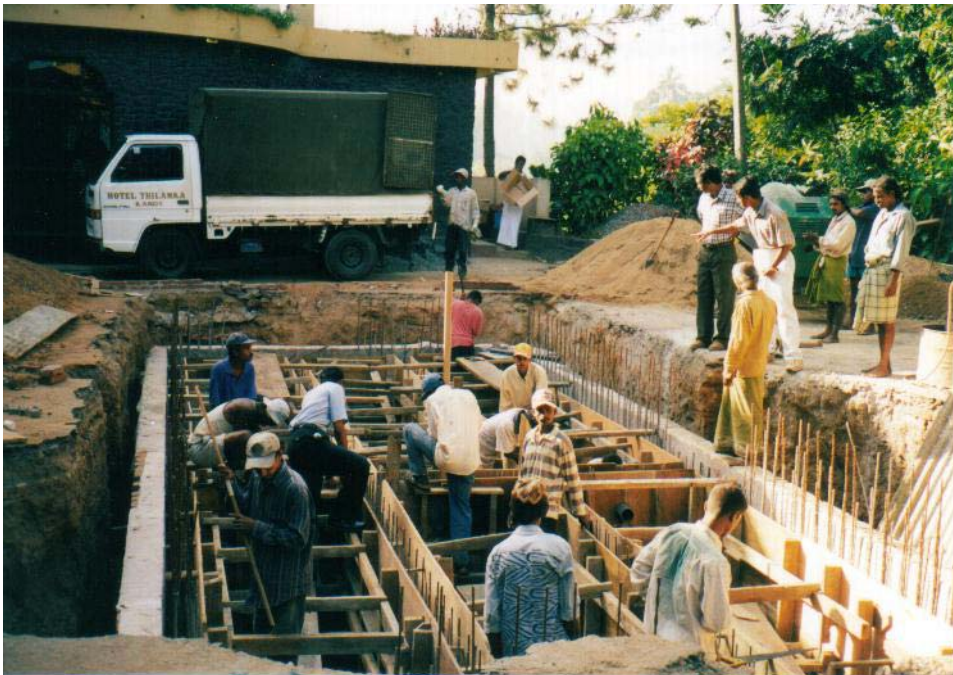
Plate 3-16. The combined septic tank – anaerobic filter unit during construction under a parking area.

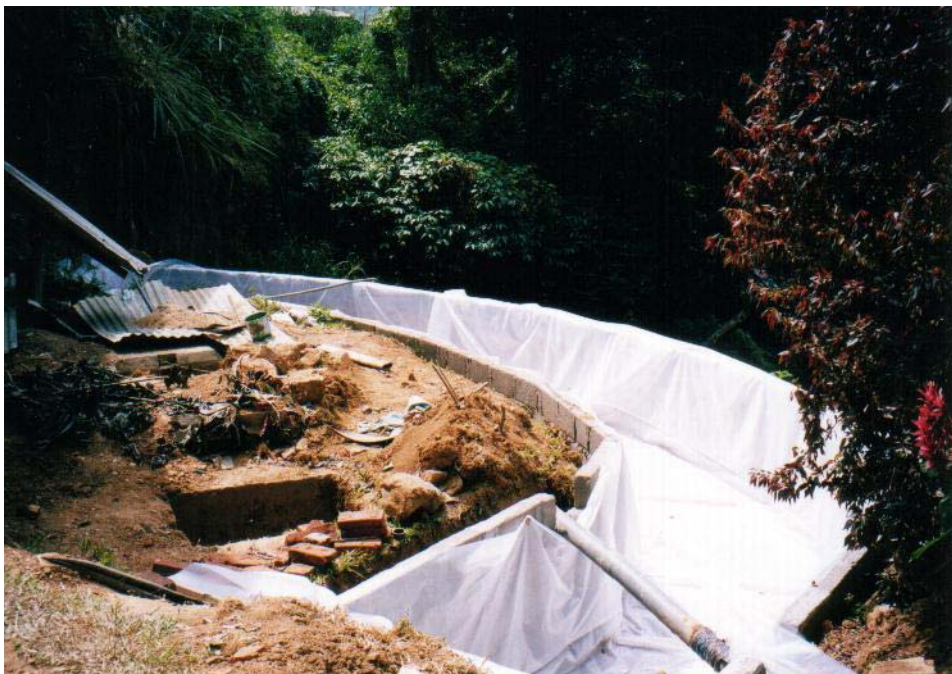
Plate 3-19. The VFPGF unit of System 2 under construction.

System 2 was located on the western side of the property, and comprised two anaerobic filter units and a VFPGF unit. The black and grey water from the western side of the old wing, together with the swimming pool wastewater, was diverted to an existing septic tank and the effluent fed to an anaerobic filter located under the western approach driveway of the hotel. The filter was configured in three parallel units. The black and grey water from the new wing was diverted to another existing septic tank, and the effluent fed to an anaerobic filter, located above ground, at the bottom of the garden, on the western side. This filter was configured in two parallel units. The effluent from both anaerobic filters was pumped separately to a VFPGF unit and the treated effluent reused for gardening on the western side. The VFPGF unit was shaped in an arc to fit into the available space and blend with the rest of the landscape. Plate 3-19 shows the VFPGF unit during the construction stage with the excavation complete and the HDPE liner in place. Plate 3-20 shows the unit in operation soon after commissioning. The influent distributor laterals are visible, spraying the influent upwards during the dosing cycle. Plate 3-21 shows the unit some weeks after commissioning with the vegetation fully established. Plate 3-22 shows the treated effluent from the VFPGF being reused for gardening.

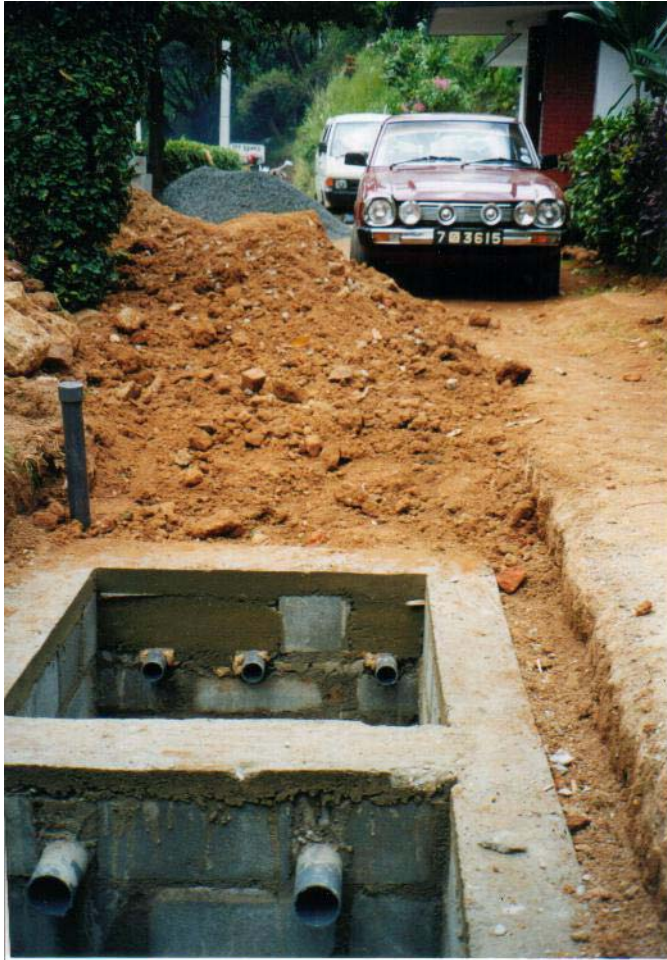
Plate 3-23. The combined septic tank-anaerobic filter unit during construction

The septic tank-anaerobic filter unit was constructed in cement block work. Plate 3-23 shows the unit being built under the front lawn, with the front entrance to the building just visible in the top right hand corner of the picture. The absorption trenches for the effluent were laid immediately beyond the unit. Plate 3-24 shows the percolation bed being laid under the garage floor.

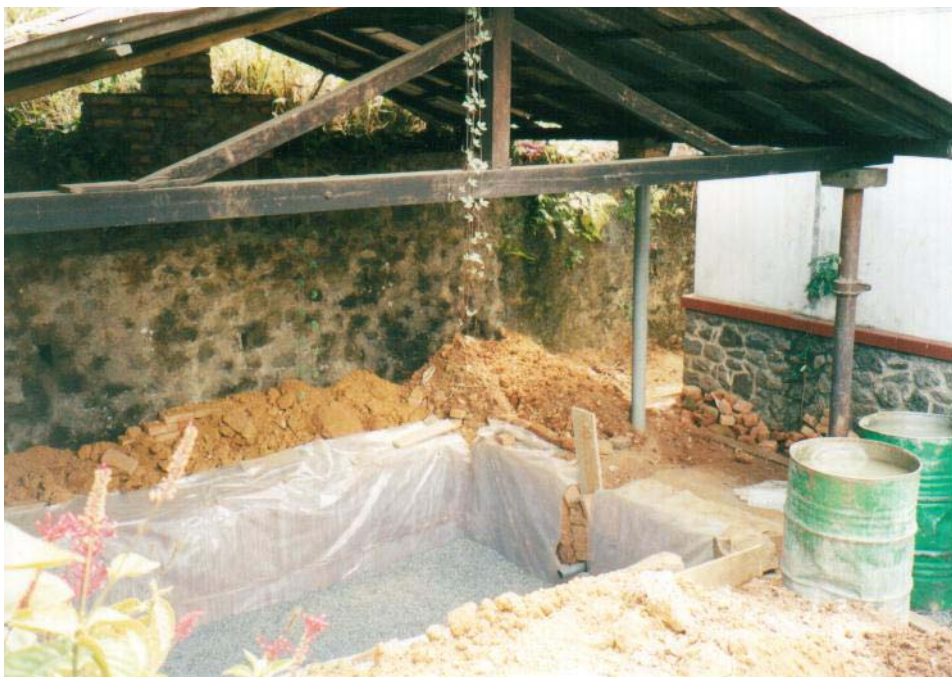
Plate 3-24. The percolation bed being laid under the garage floor.

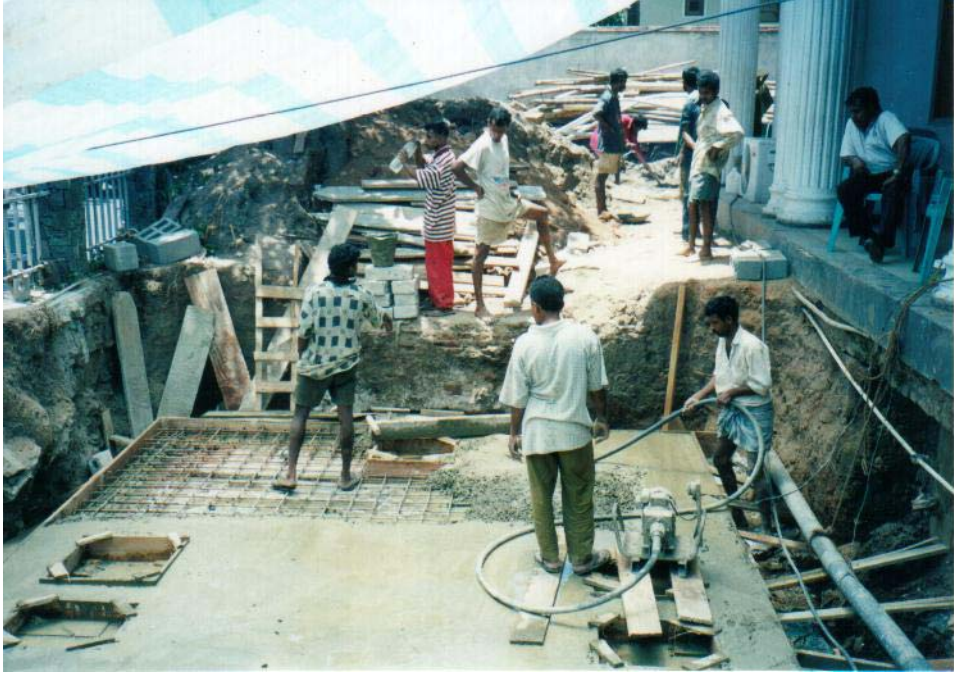
Plate 3-26. The cover slab of the anaerobic filter being laid during construction

Plate 3-25 shows a view of the hotel building. Plate 3-26 shows the cover slab of the anaerobic filter being laid during construction. The entrance colonnade of the hotel is visible in the upper right of the picture and the front boundary fence on the upper left. The anaerobic filter unit fits in the space between with less than one metre clearance on either side. Plate 3-27 shows the same area after completion of construction and relaying of the lawn. The anaerobic filter lies under the foreground area of the picture and the percolation bed lies immediately beyond, in the background area. Plate 3-28 shows the VFPGF unit immediately after planting and commissioning. Influent dosing is in progress, with the influent being sprayed upwards into the air through the distributor laterals. Plate 3-29 shows the VFPGF unit a few weeks later with the vegetation well established. Broad-leaved plants (*Cannas* spp., and *Coleus* spp.) were selected to maximize evapo-transpiration from the bed. This was necessary to minimize discharge of effluent into the roadside drain as much as possible, as the drain was shallow, and of low capacity.

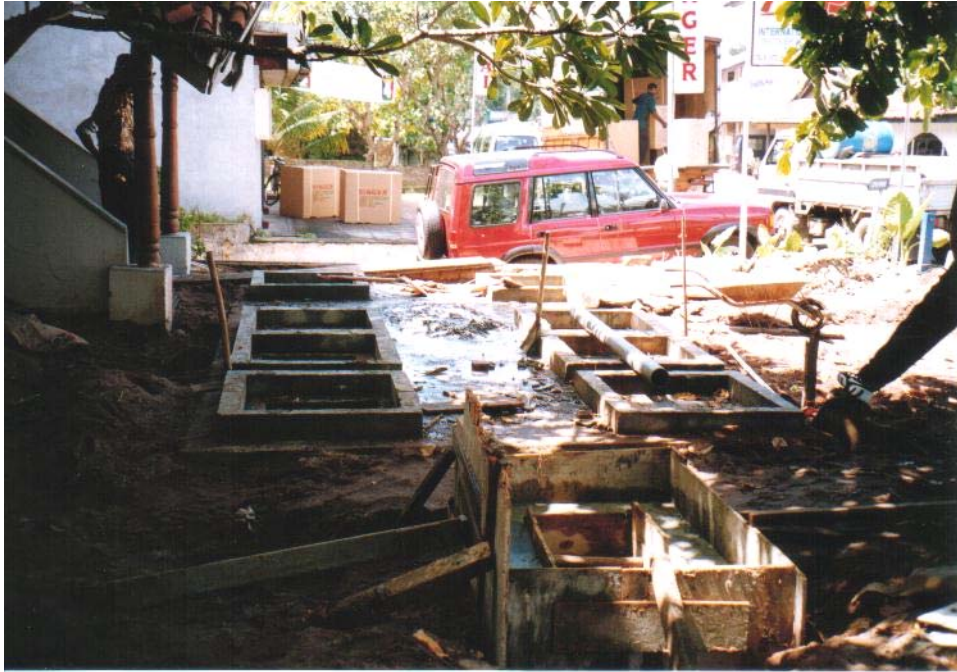
Plate 3-31. Combined septic tank-anaerobic filter unit nearing the end of construction

hotel building on the land side of the road. The unit was located immediately in front of the steps and constructed in cement block work with reinforced concrete infill to reduce cost. The access manholes are visible in the picture. These were fitted with heavy-duty covers to withstand the weight of large tourist buses, which are sometimes parked here. Plate 3-32 shows the VFPGF unit with the bed partially laid. A layer of limestone was laid at the bottom of the bed to buffer the pH of the effluent. The limestone layer is visible in the foreground of the picture. The partially laid layer of stone chips, which made up the rest of the bed, is visible in the background. Plate 3-33 shows the VFPGF immediately after planting. Shading of the bed was required, until proper vegetation cover was established, in order to prevent heating up of the stone chips in the bed by the sun. The VFPGF was located just outside the staff accommodation rooms, the windows of which can be seen in the picture. The setback distance was less than a metre.

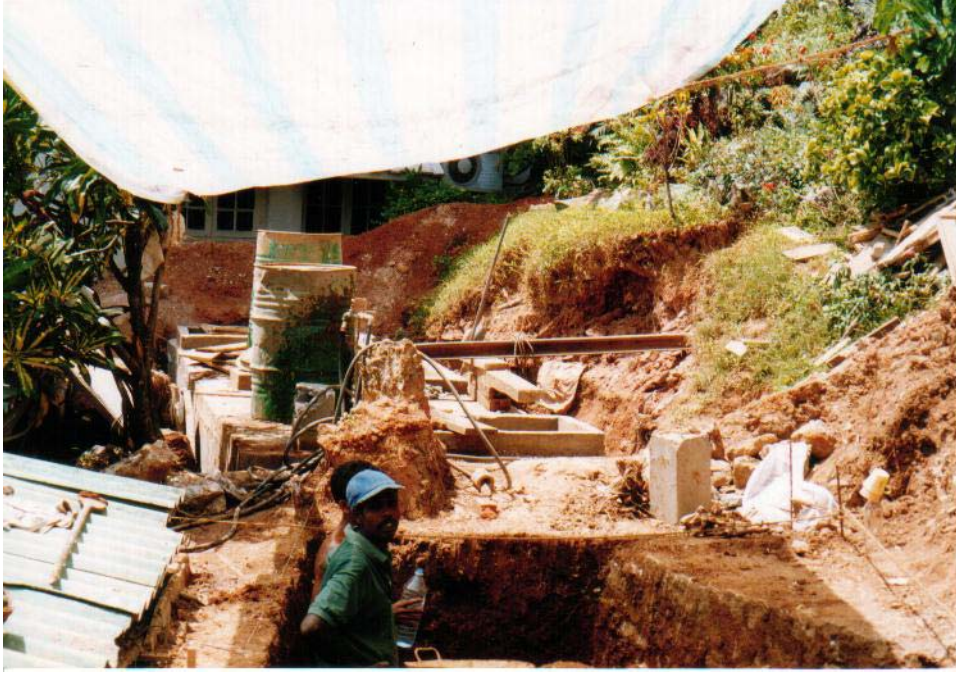
Plate 3-35. The treatment units under construction.

The treatment units were located beside the main hotel building on a patch of terraced garden. Plate 3-34 shows a view of the hotel as seen from a hill on the opposite side of the lake. The steeply sloping terrain is typical of the hillsides surrounding the Kandy Lake. The hotel buildings are in the centre of the picture. The treatment units were located in the garden area immediately to the right of the main building, above the swimming pool, at the third floor level. Plate 3-35 shows the treatment units under construction on a narrow garden terrace. The nearly complete anaerobic filter is visible in the centre of the picture, and the excavation for the VFPGF is partly visible in the foreground. In the background are the windows of the third floor of the hotel building, which open out on to the terrace.

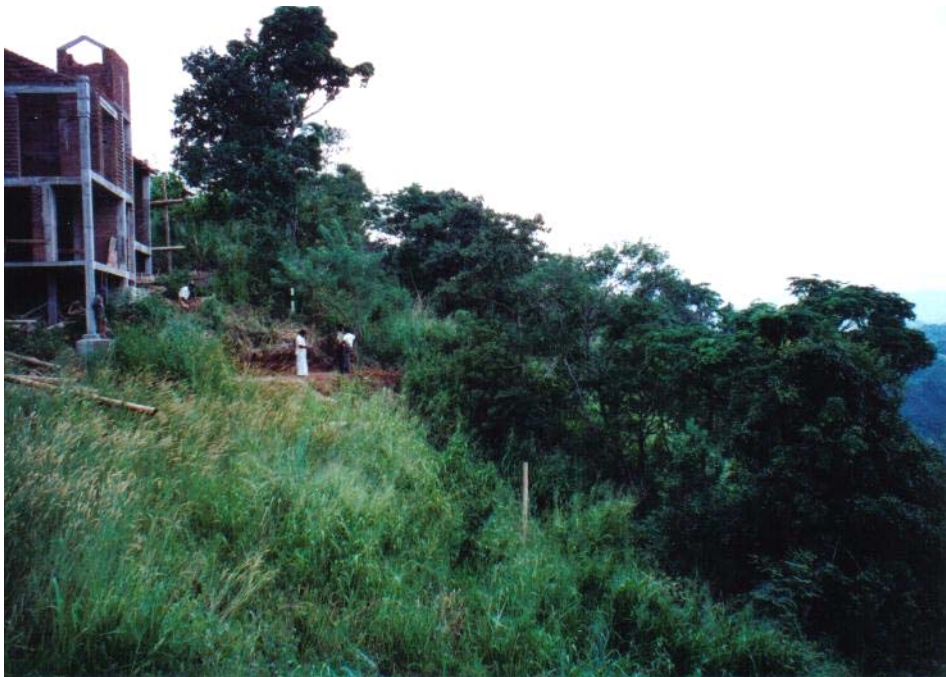
Plate 3-36. Site for treatment units prior to commencement of construction

Plate 3-36 shows the house during the early stages of construction, with the site for the treatment units cleared and levelled prior to construction. The land falls away steeply to the right in a near-vertical cliff face. Plate 3-37 shows the treatment system after construction, prior to commissioning. All the units including the septic tank were built above ground due to the presence of bedrock at almost ground level. The percolation bed was kept open. The septic tank unit is on the left, the reed bed is in the centre and the percolation bed is towards the right of the picture. The percolation bed and reed bed were contained in a rubble masonry structure, as rubble was freely available on the site. Several months after commissioning, the percolation bed was converted into a VFPGF at the owner's request, for aesthetic reasons. Plate 3-38 shows the reed bed approximately a year after commissioning. The reeds had been gradually phased out and replaced by flowering plants, mainly *Cannas* spp. and *Coleus* spp. by the owner. The simple swivelling elbow device at the outlet, which is used to control the water level in the reed bed, is visible in the foreground of the picture. Plate 3-39 shows the percolation bed after being converted to a VFPGF.

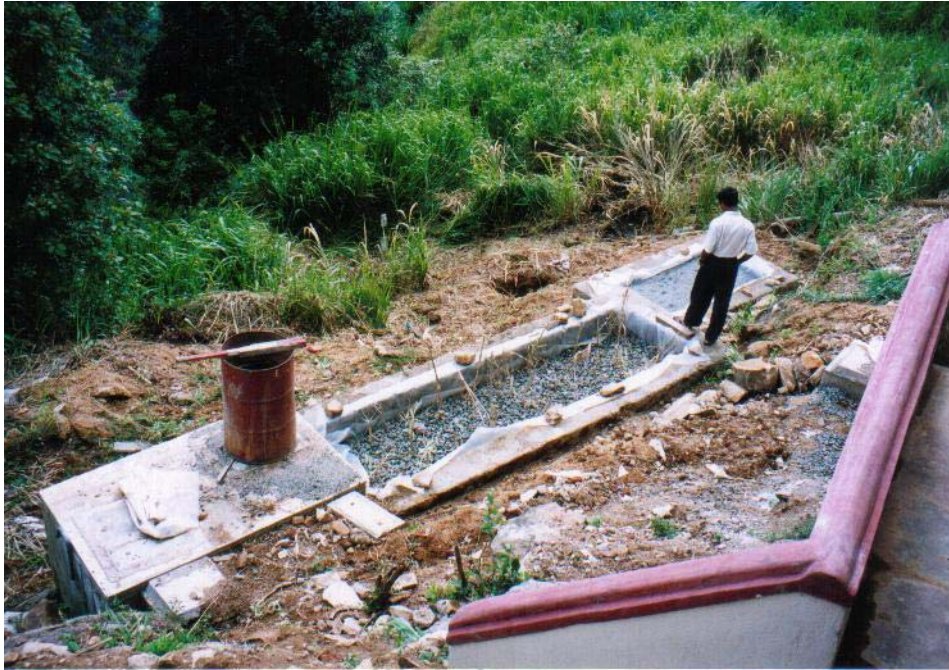
Plate 3-37. The constructed treatment system prior to commissioning

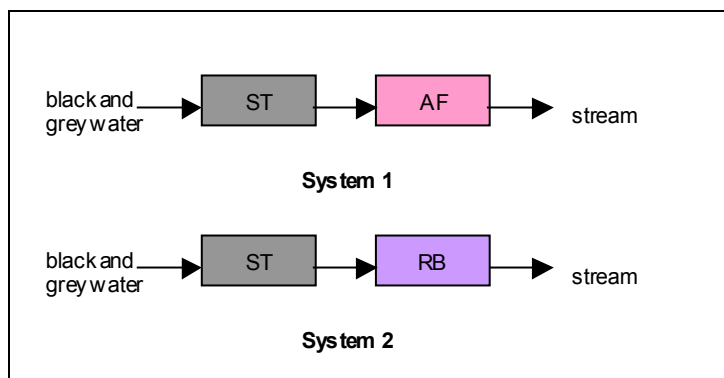
Figure 3-17. Process flow diagrams for the Ranpokunugama treatment systems.

Ranpokunugama was a large, government funded, middle class urban housing development of several hundred housing units, situated in the Gampaha district, 50 kilometres northeast of Colombo. The scheme was approximately 25 years old and had originally been equipped with many large septic tanks and soakage pits serving between 20 to 40 housing units each. However, several of the soakage systems had failed. Two systems were designed and implemented to rectify two of the worst failures. The process flow diagrams of the two systems are given in Figure 3-17.

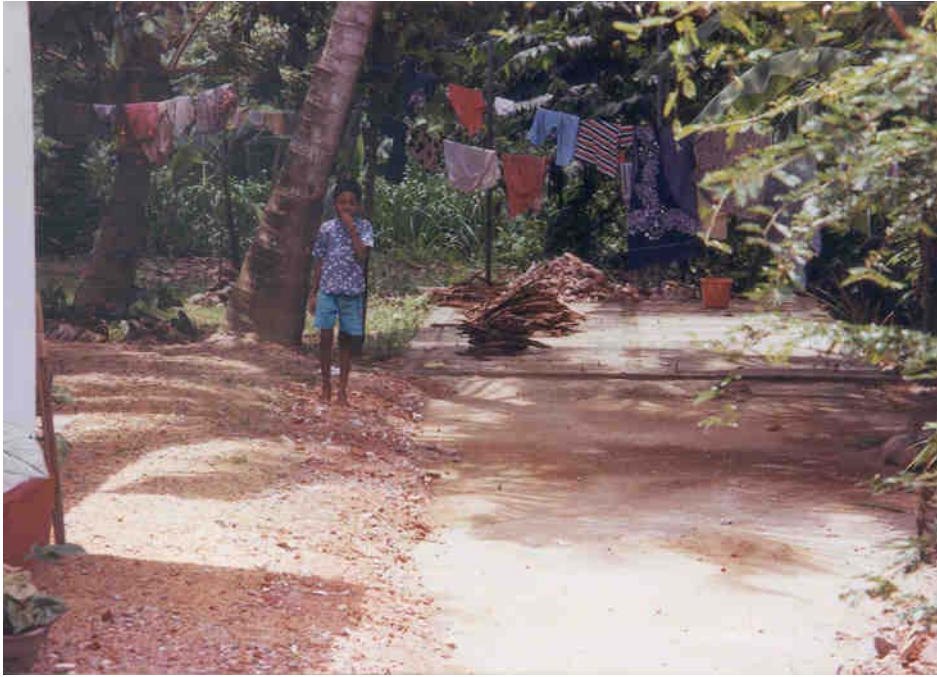
Plate 3-40. The anaerobic filter unit at Ranpokunugama after commissioning

System 1 was to rectify a septic tank with three soakage pits serving 23 housing units in the scheme. The original septic tank and soakage pits were located in the garden of one of the houses. The soakage pits had failed and septic tank effluent was overflowing into the garden and flowing into an adjacent stream. An anaerobic filter, comprising two parallel units, was designed and installed to replace the soakage pits, and the treated effluent was diverted to the stream. The filter unit was located adjacent to the septic tank in the same garden. Plate 3-40 shows the anaerobic filter unit after several months' operation.

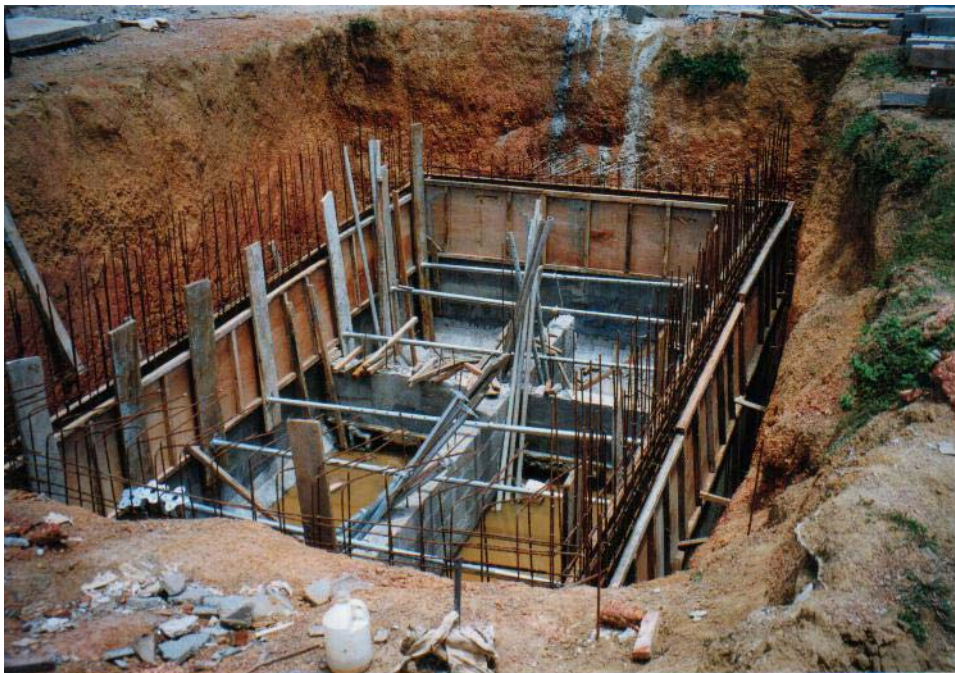
Plate 3-42. A septic tank unit under construction

Plate 3-41 shows a view of the housing scheme nearing completion. Plate 3-42 shows one of the septic tank units under construction. Hard lateritic soil, which was present below one metre depth at the site, is visible in the picture. This soil is highly impermeable and precluded any option for soakage. Plate 3-43 shows one of the reed bed systems during early stages of construction. The beds were contained within cement block work walls, with the individual channels being separated by HDPE liners. Plate 3-44 shows a simplified sewer line being laid along an alleyway, and Plate 3-45 shows the ‘Wye’ junctions with removable cleaning doors, which were used for house connections. These fittings are available locally, and this was the first time they were introduced in a large housing scheme in Sri Lanka.

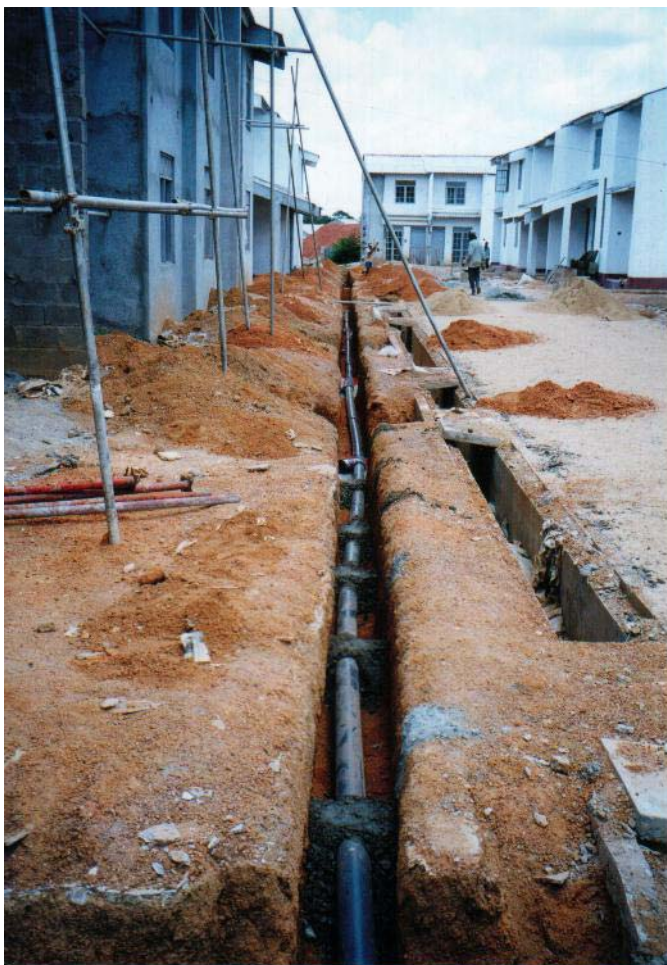
Plate 3-44. A simplified sewer line being laid.

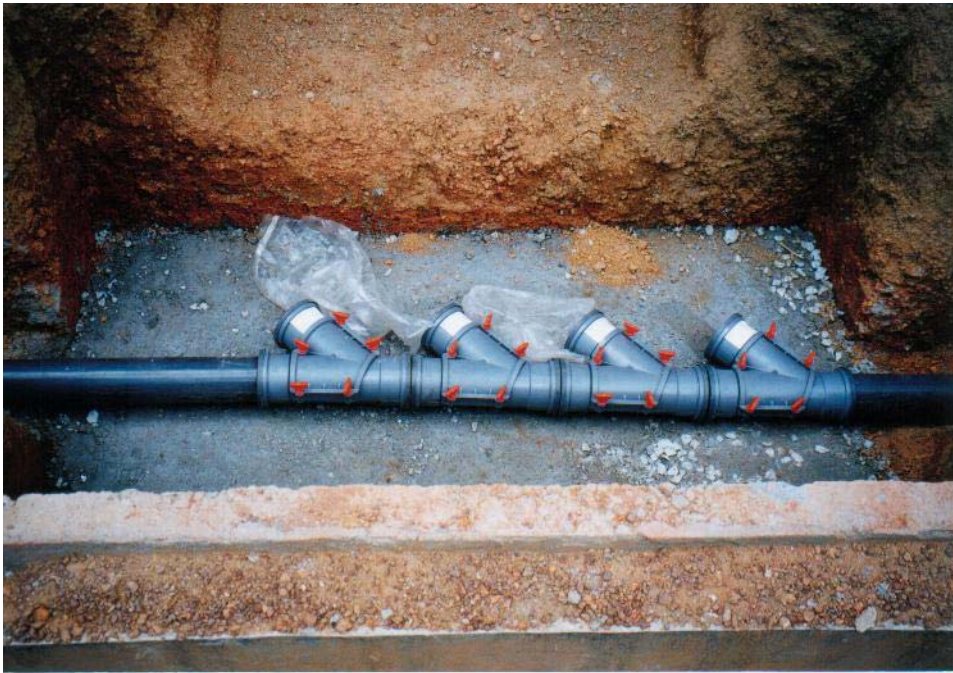
Plate 3-45. House connections with removable cleaning doors during installation.

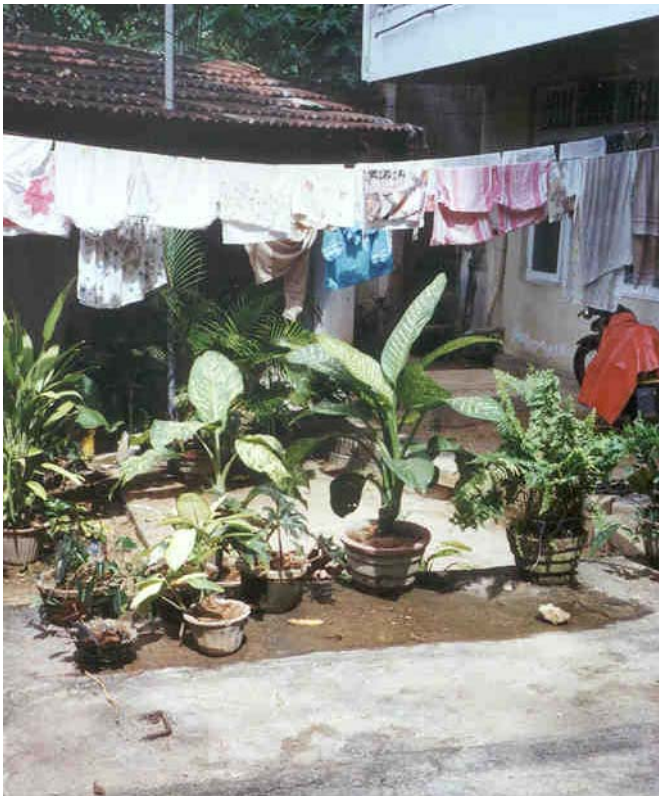
Plate 3-47. The anaerobic filter unit.

Plate 3-46 shows a view of the building from the rear. The treatment system is buried under the back yard. Plate 3-47 shows the anaerobic filter unit with clothes hung out to dry above it. The setback distance to the unit and the effluent discharge point from the closest room is less than 3 metres.

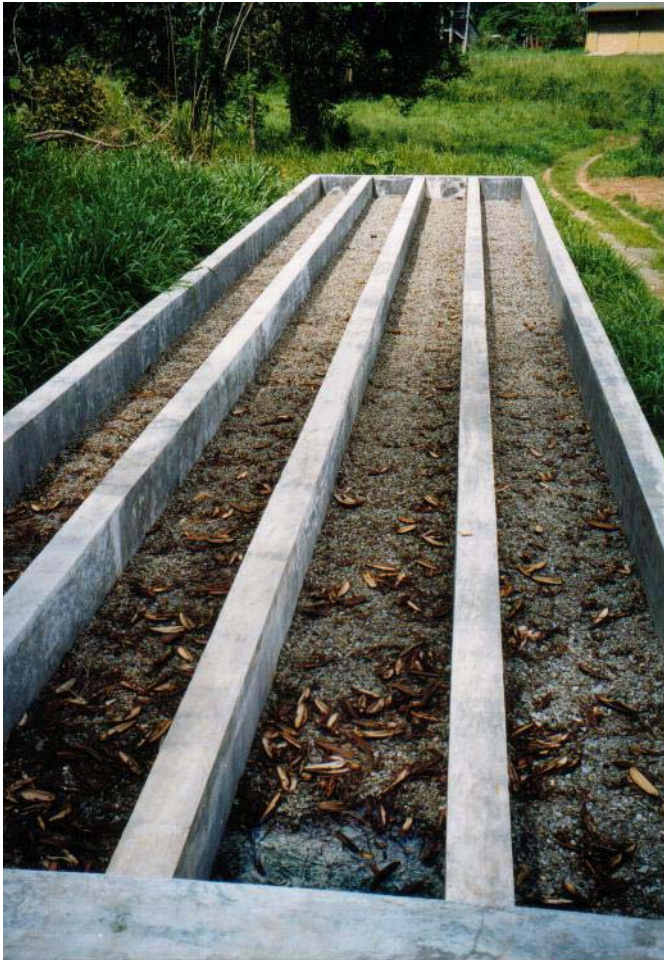
Plate 3-48. One of the reed bed stages at Akbar-Nell, soon after construction.

The reed beds were built entirely above ground level, with four parallel channels each, contained within rubble masonry walls. The bottom of the beds was lined with a layer of puddle clay and an HDPE liner, and the beds were laid with stone chips. Plate 3-48 shows one of the reed bed stages after completion of construction, before vegetation was established. Plate 3-49 shows a reed bed channel after establishment of vegetation and several months' operation. Plate 3-50 shows a septic tank being built beside one of the dormitory wings of the Hall.

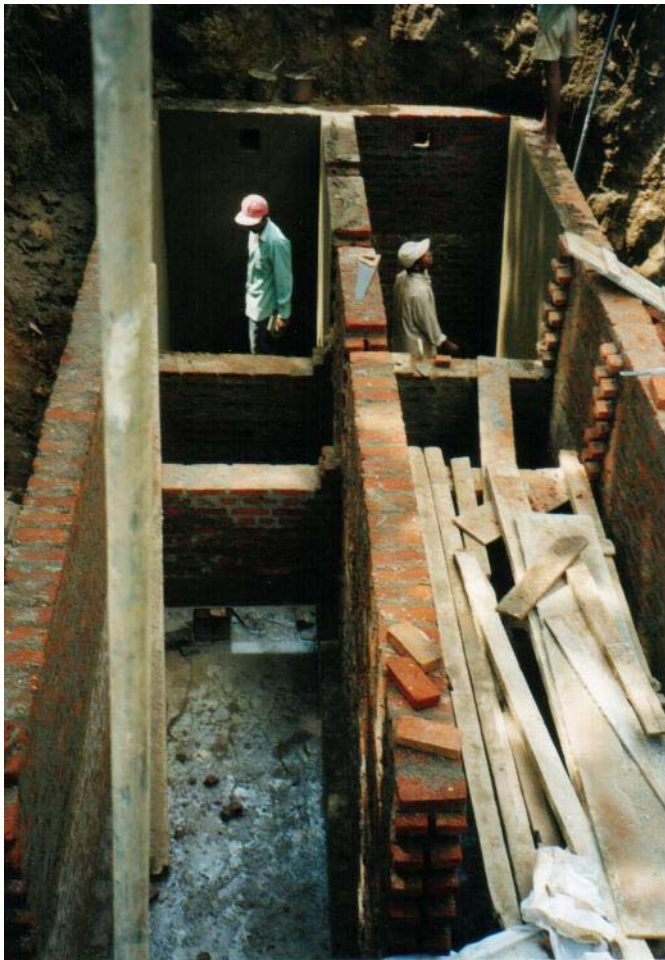
Plate 3-51. The combined septic tank-anaerobic filter under construction.

The wastewater from the restaurant kitchen was pretreated in a grease trap before being fed to the septic tank. The treated effluent was discharged to the drain. The entire system was designed to be gravity flow, even though this meant that the septic tank and anaerobic filter unit had to be buried as much as one and a half metres below the ground. This was done because it was not considered likely that the centre staff would be capable of adequately maintaining a pumped system. Plate 3-51 shows the combined septic tank-anaerobic filter unit under construction. The unit was built as two parallel systems. Plate 3-52 shows the access manholes, which were raised by approximately one and a half metres to bring them up to ground level. The building complex is visible in the background.

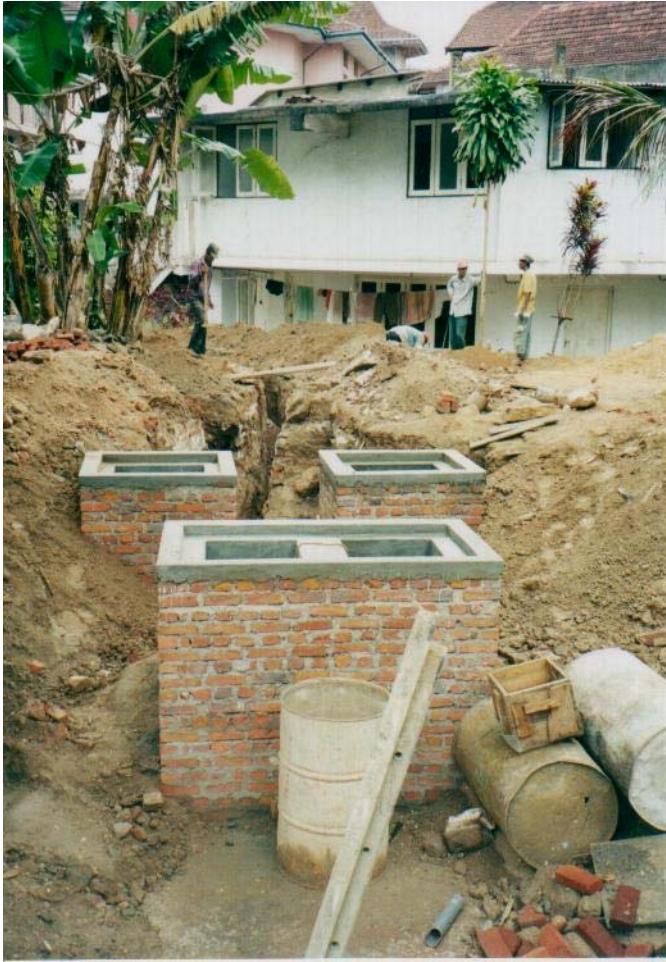
Plate 3-52. The raised access manholes of the septic tank-anaerobic filter.

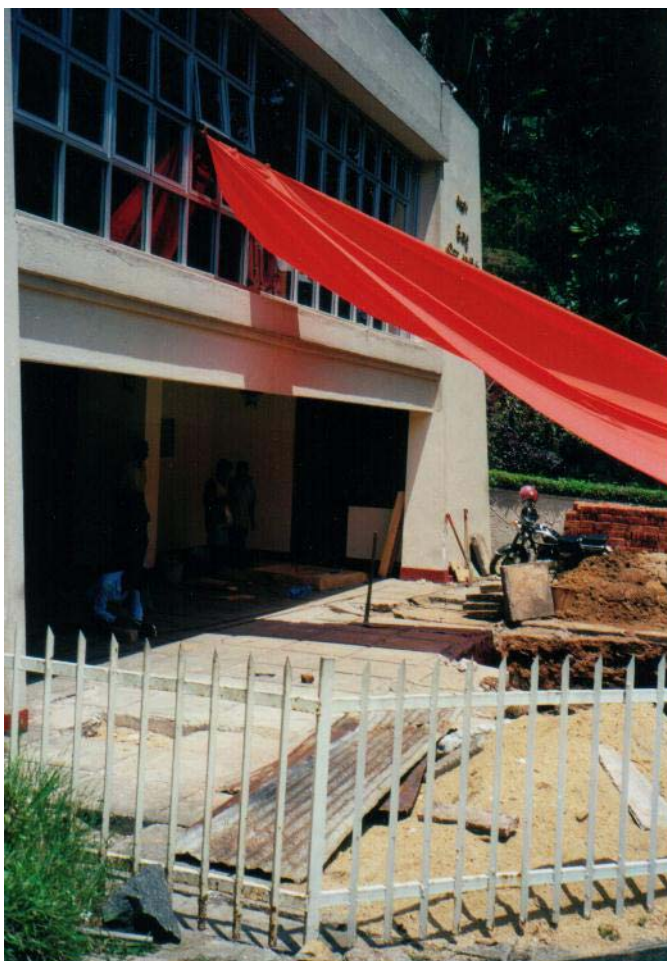
Plate 3-53. The anaerobic filter under construction at Sampath Hall.

Plate 3-53 shows a portion of the Sampath Hall building, with the anaerobic filter under construction under the entrance forecourt. The setback distance to the entrance hall is approximately two metres. Plate 3-54 shows the entrance forecourt after completion of construction.

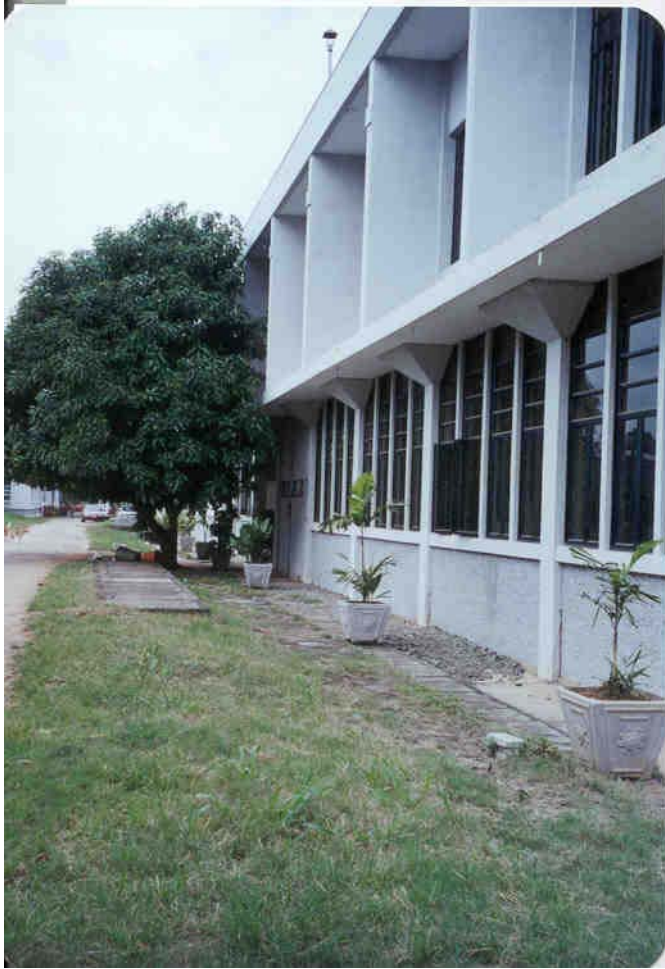
Plate 3-55. A view of the Library complex.

Plate 3-55 shows a view of the Engineering Library Complex. The septic tank and anaerobic filter are visible in front of the tree in the picture. Setback distances to the building and the frequently used footpath on the left of the picture are less than two metres each.

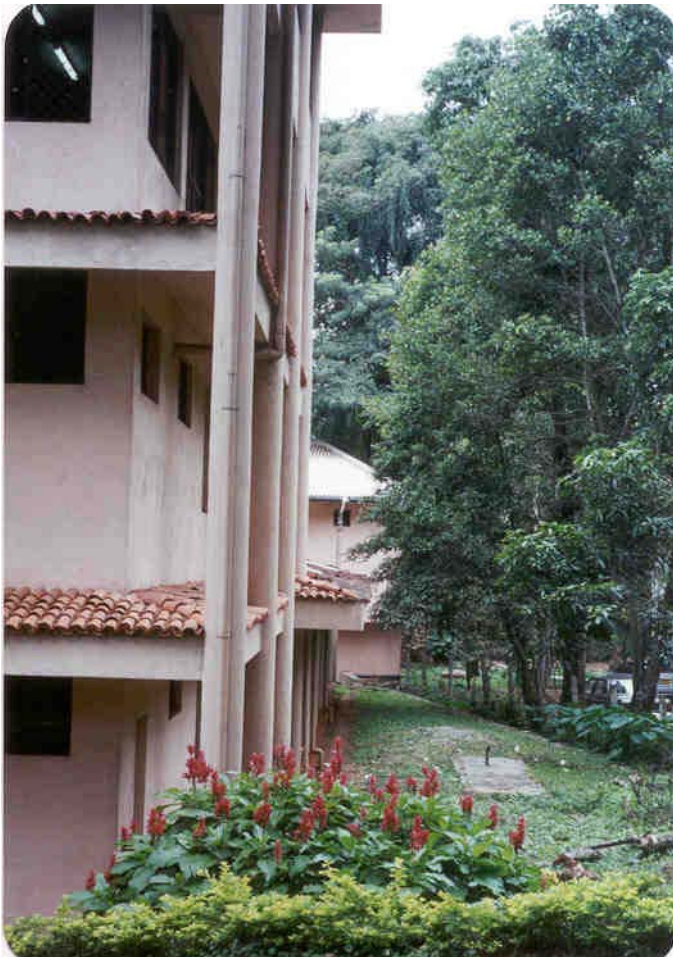
Plate 3-56. A view of the PGIA Library complex with the anaerobic filter beside it.

Plate 3-56 shows a part of the library and auditorium complex. The top slab of the anaerobic filter unit is visible on the lawn to the right of the picture. The effluent is discharged to a drain running along the edge of the lawn on the right. Plate 3-57 shows a view of the drain at the point of effluent discharge.
