4. RESULTS AND DISCUSSION

4.2. The Swiss Residence, System 1

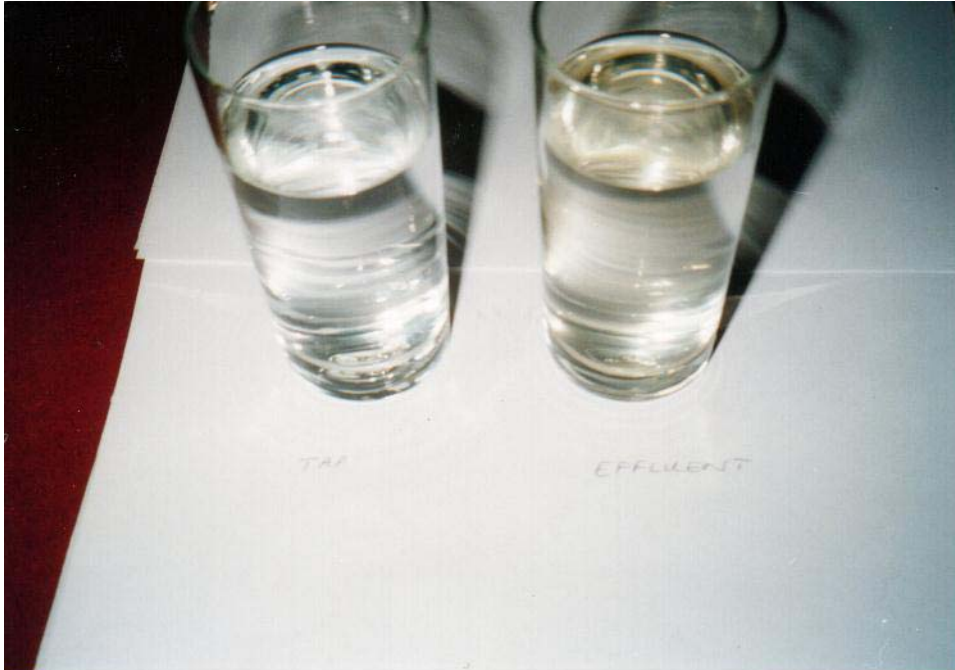
Plate 4-1 shows a typical sample of treated effluent from system 1, compared to drinking water from a tap. The tap water sample is on the left and the treated effluent on the right of the picture.

Plate 4-1. A typical effluent sample from system 1 compared to tap water.

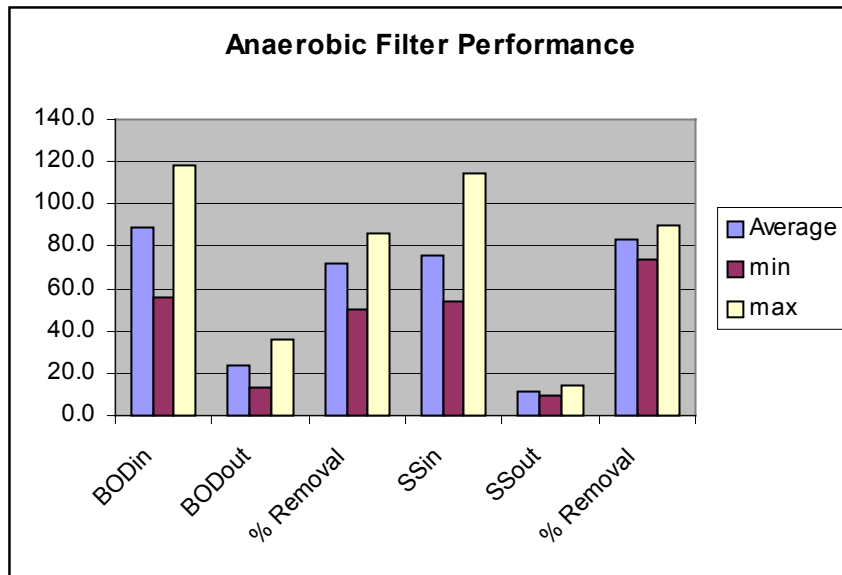
Figure 4-2. Performance characteristics of the Swiss Residence Anaerobic filter.

As can be seen from the figure, the anaerobic filter produced a consistent effluent quality in terms of both, BOD and suspended solids, despite a wide variation in influent quality. The effluent from the unit was almost invariably within the SLS standards for discharge into inland surface waters. The mean effluent concentration was 23.2 mg/l BOD₅ and 11.7 mg/l suspended solids. The range was between 12 and 36 mg/l for BOD, and 9.6 and 14.0 mg/l for suspended solids. The removal efficiency for BOD varied from 50 to 86 percent, with a mean of 72.2 percent. The removal efficiency for suspended solids varied from 74 to 90 percent with a mean of 83.4 percent. The filter did not provide significant removal of turbidity and faecal coliforms, with less than 20 percent removal of turbidity. The pH of the wastewater typically dropped two points between the inlet and outlet of the filter. The influent pH was consistently between 7.0 and 7.3, while the effluent pH was consistently between 6.9 and 7.2.

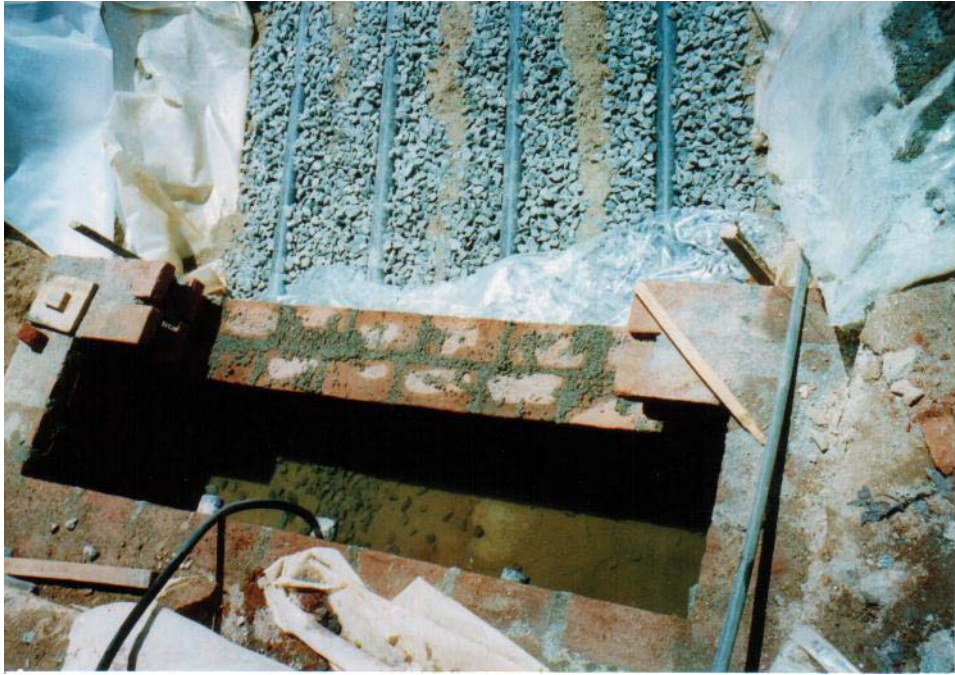
During its second year of operation, due to pressure from neighbours and regulators, the hotel management diverted the kitchen effluent as well, to the treatment system. Initially, this did not cause any problems other than an increase in the occurrence of the gas blocks in the anaerobic filter. However, after a few weeks of operation in this mode, the effluent flow rate from the percolation bed decreased gradually, and the system began to back up due to clogging of the percolation bed. The bed was rested for a period of six weeks after which it recovered, partially, but soon clogged again after the flow was restored. Subsequently, the bed was re-laid with a layer of stone chips at the bottom of the filter, with a gravel layer above. When the bed was opened up for relaying, it was found that the clogging had occurred mainly in the gravel around the single effluent collector pipe, which was laid laterally across the bottom of the bed at the outlet end of the bed. Also, it was found that the influent flow was not being distributed evenly over the bed, as the influent distributor pipes had not been laid at the same level during construction. This had resulted in approximately half of the bed being largely unused. A new distributor box was constructed, and the distributor pipes were laid at true level. The effluent collector arrangement was changed to comprise four, parallel, perforated pipes running along the length of the bed at equal spacing. Plate 4-2 shows a plan view of the new arrangement of collector pipes and Plate 4-3 shows the bed being re-laid with a layer of stone chips at the bottom. The original effluent collection arrangement was a single perforated pipe, laid laterally across, at the far end of the bed.

Plate 4-2. The new arrangement of the effluent collector pipes being laid.

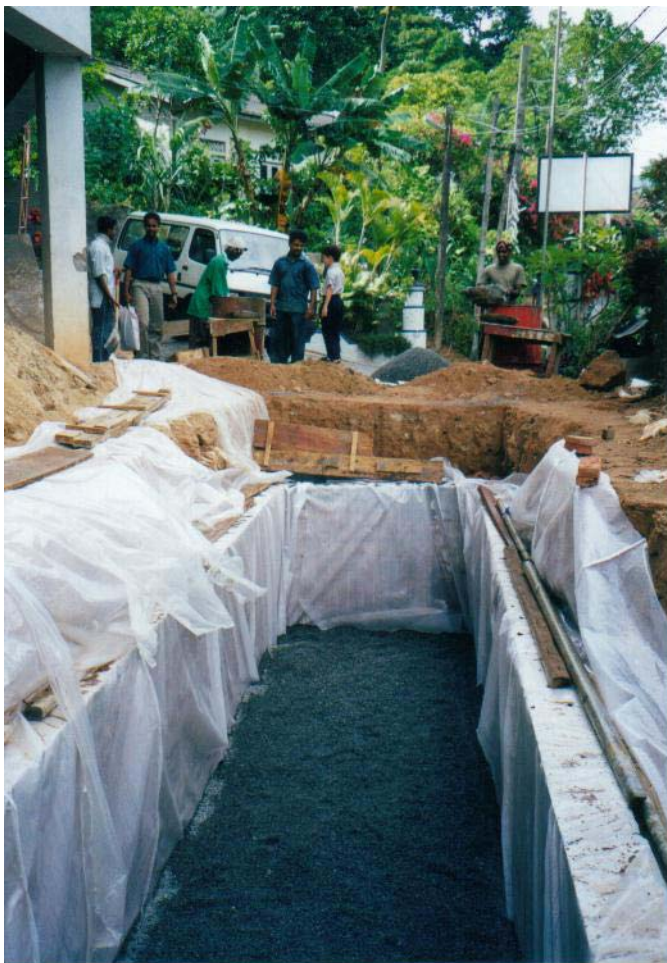
Plate 4-3. The percolation bed being re-laid with stone chips.

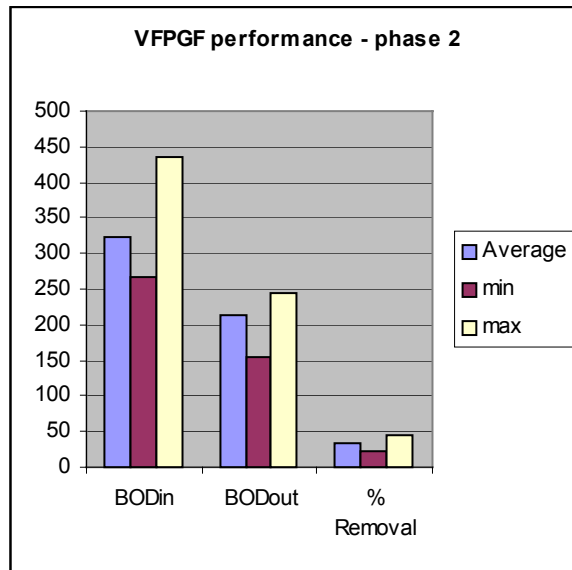
Figure 4-5. BOD₅ removal by the VFPGF unit during phase 2

As can be seen in the figure, the mean influent concentration rose sharply to 324 mg/l BOD₅, and the range was between 266 and 435 mg/l BOD₅. The percentage removal dropped to a mean value of 33 percent and a range of 21 to 44 percent. The effluent was turbid, milky white, in appearance and had a strong sour odour. The effluent pH was elevated by, typically, 5 to 6 points to around 5.6 by the VFPGF unit. However, it was evident that the unit could not cope effectively with the low pH of the septic tank effluent. Figure 4-6 shows the variation of removal efficiency vs. pH for the VFPGF unit, which exhibits a near linear decrease in removal efficiency with decrease in pH below 7.

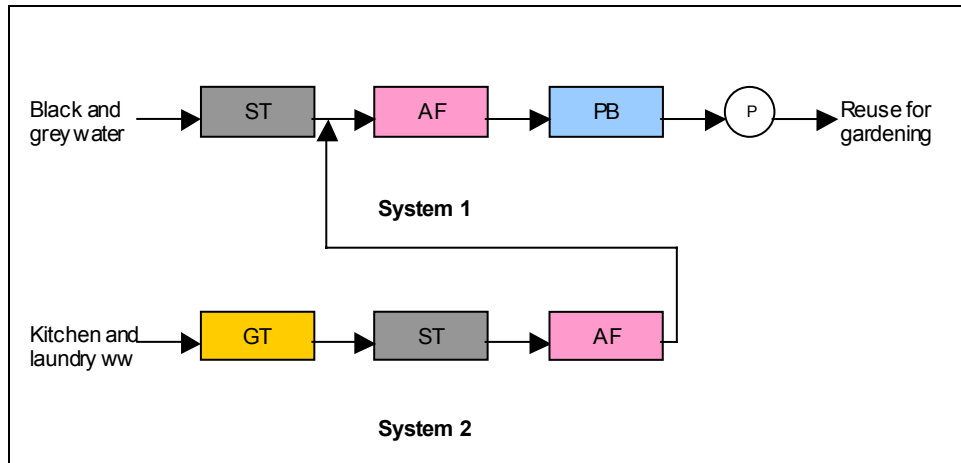
working well for a period of three months, with the anaerobic filter and percolation bed of system 1 coping well with the additional load, without signs of stress or a drop in the overall effluent quality of system 1. Figure 4-7 shows the current configuration of the two treatment systems.

Figure 4-7. Current configuration of Swiss Residence treatment systems.

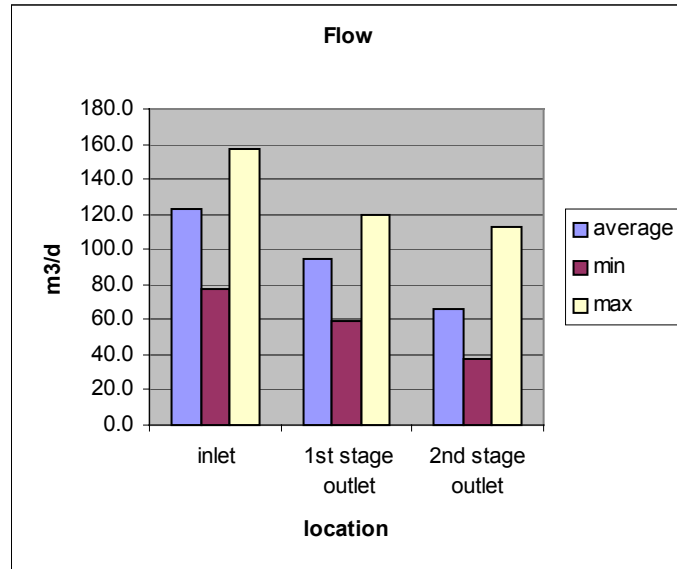
the two outer channels of the beds, could not be utilized due to leaks arising from construction defects, which had not been rectified. Figure 4-8 shows the basic flow characteristics through the reed bed system.

Figure 4-8. Wastewater flow through the reed bed system.

The flow to the inlet of the first stage ranged between 77.5 m³/d and 158 m³/d, with a mean of 123.2 m³/d. This flow reduced to a mean of 94.6 m³/d and a range of 59 to 120 m³/d by the outlet of the first stage. This reduction was mainly due to seepage through the bottom of the bed, due to shoddy construction, rather than evapotranspiration by the plants, as the reduction in flow was present, virtually unchanged, when the beds were not vegetated. The flow in the second stage of the filter reduced even further, dropping to an average of 65.5 m³/d and a range of 38 m³/d to 113 m³/d at the outlet. Figure 4-9 shows the individual flow characteristics of the two channels that were in operation.

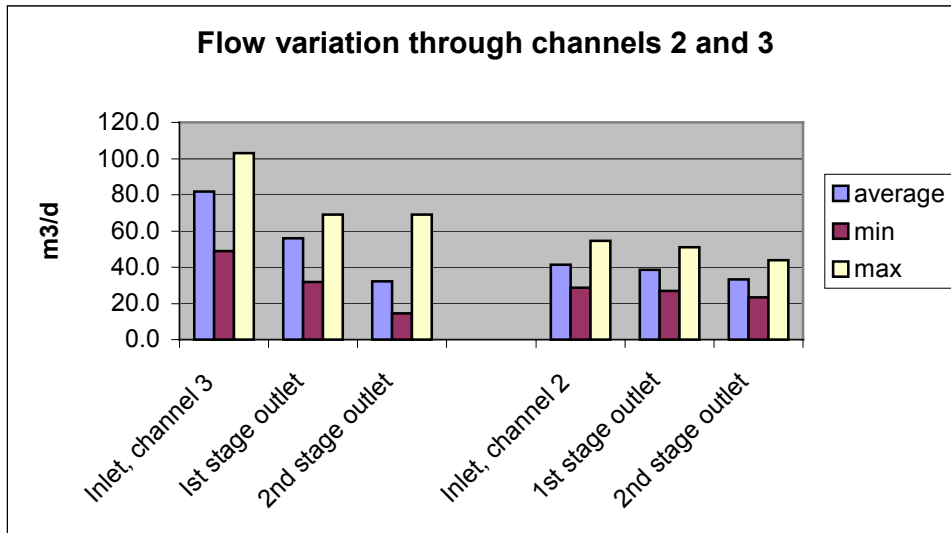
Figure 4-9. Flow characteristics of the individual reed bed channels

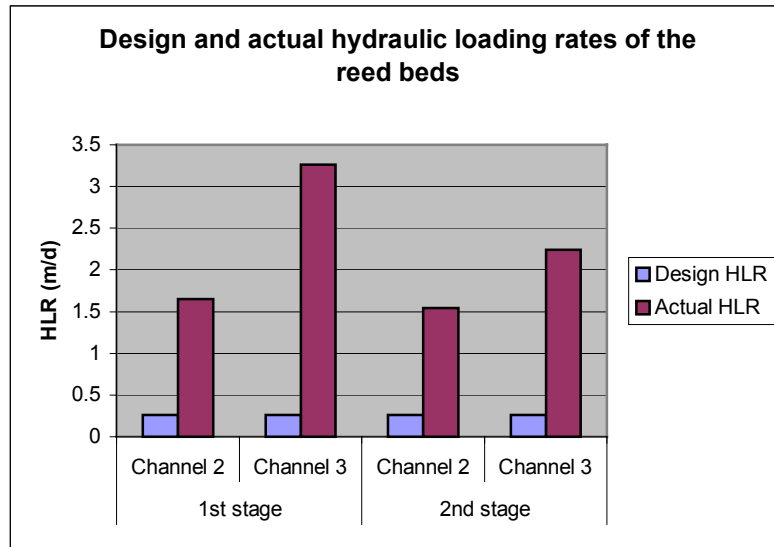
The 1st stage bed of channel 3 has experienced the highest hydraulic loading rate with an average of 12.5 times the design value, while the 2nd stage bed of channel 3 has experienced the highest organic overload, with 6.8 times the design organic loading rate. In actual terms, however, the 1st stage bed of channel 3 has experienced the highest organic loading rate with 135 gBOD/m².d. Figure 4-10, Figure 4-11, and Figure 4-12 present a graphical representation of these results.

Figure 4-10. Comparison of design and actual hydraulic loading rates

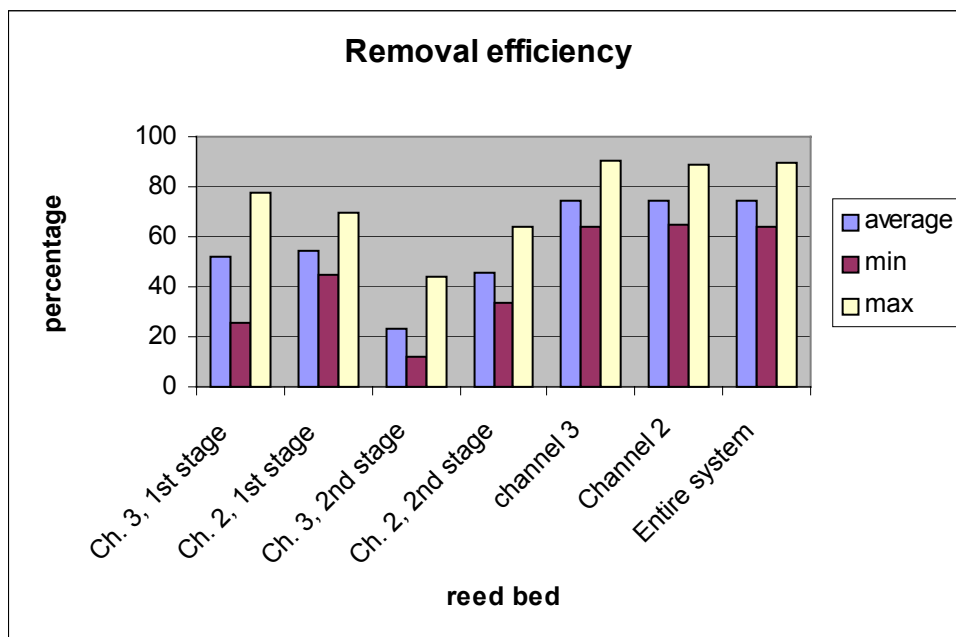
Figure 4-16. BOD removal efficiencies for the reed bed system

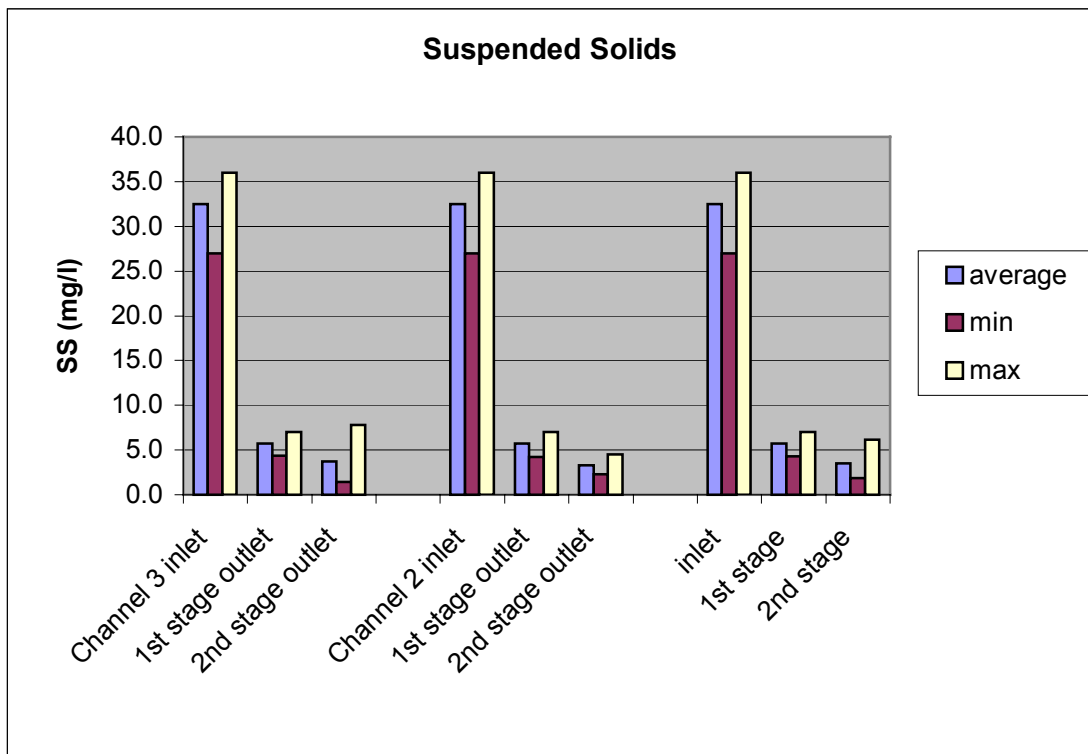
Figure 4-17 shows the inlet and outlet concentrations of suspended solids of the individual reed beds as well as for the system as a whole.

Figure 4-17. Performance of the reed beds in terms of Suspended Solids.

As can be seen in the figure, the effluent quality of all the beds was excellent in terms of suspended solids. Here, too, the influent concentrations were slightly lower than the anticipated values, due to dilution of the raw sewage with water from the leaking toilet fixtures. The mean influent concentration was 32.5 mg/l SS, with a range of 27.0 to 36.0.

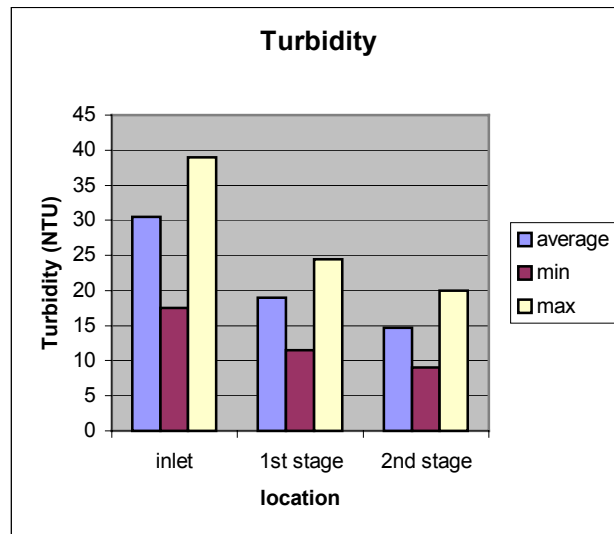
Turbidity declined steadily through the reed beds, as can be seen in Figure 4-18, which shows the variation of turbidity through the reed bed stages.

Figure 4-18. Variation of turbidity through the reed bed stages.

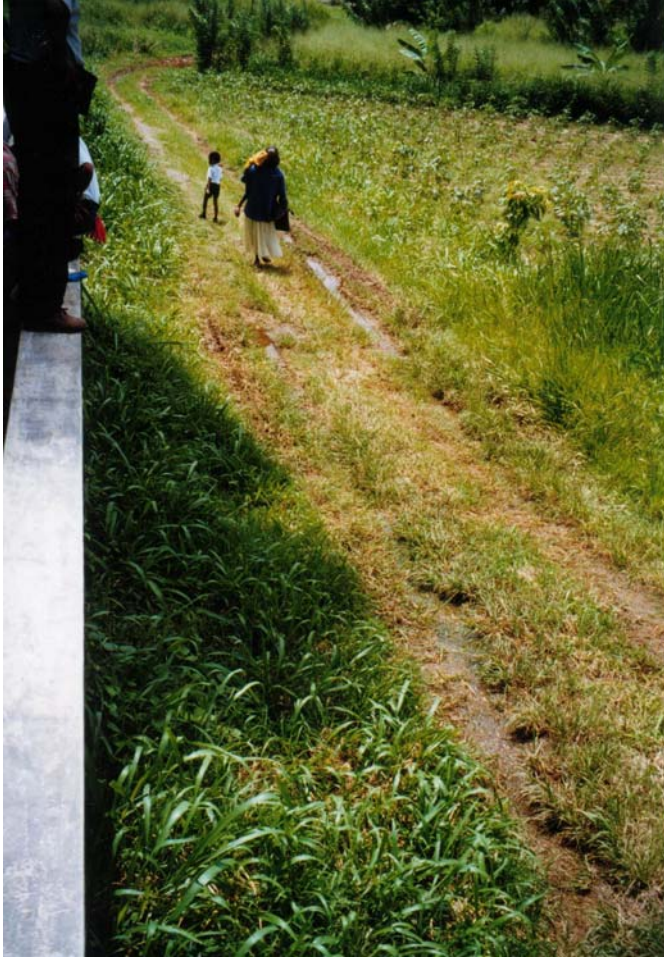
The operation and maintenance of the Akbar-Nell treatment system was, officially, the responsibility of the University maintenance division, which was the same organization responsible for the maintenance work of the other Hall facilities as well. The approach of the maintenance division was to ignore the system unless some sort of crisis was brought to their notice. Once the system was built, the sewage was connected, without the beds being vegetated. This condition prevailed for several months. An effluent channel was not built to convey the final effluent to the stream, which was the intended discharge point. Instead, the effluent was left to meander along the ground and finally flow along a gravel road passing by the reed bed system. This was compounded by the fact that the two outer channels of the reed beds had severe leaks due to construction defects. The flow when applied to these channels would not arrive at the outlet point. Instead it would leak out from under the beds and flow along the gravel road. The maintenance reaction was to shut down the two outer channels. However, the inner channels too, had leaks though not as severe, which is evident from the flow data presented in Figure 4-9 of section 4.4.1 above. This eventually resulted in the passers by who used the road on a regular basis, taking matters into their own hands and shutting the control valve to the reed beds. This further compounded the problem by causing, the raw influent to overflow from the flow distribution box and meander along the ground, causing severe problems of odour in the vicinity. Meanwhile, untended vegetation growing wild around the beds, invaded the outer channels, covering them up completely. In essence, the institution concerned demonstrated a consistent lack of will and ability to perform simple maintenance activities, such as repairing of leaks, cutting an effluent channel, maintenance of vegetation etc. Plate 4-4 shows the gravel road beside the treatment system which became completely saturated and waterlogged with leaking sewage from the reed beds.

Plate 4-4. The gravel road beside the system waterlogged with leaking sewage from the beds.

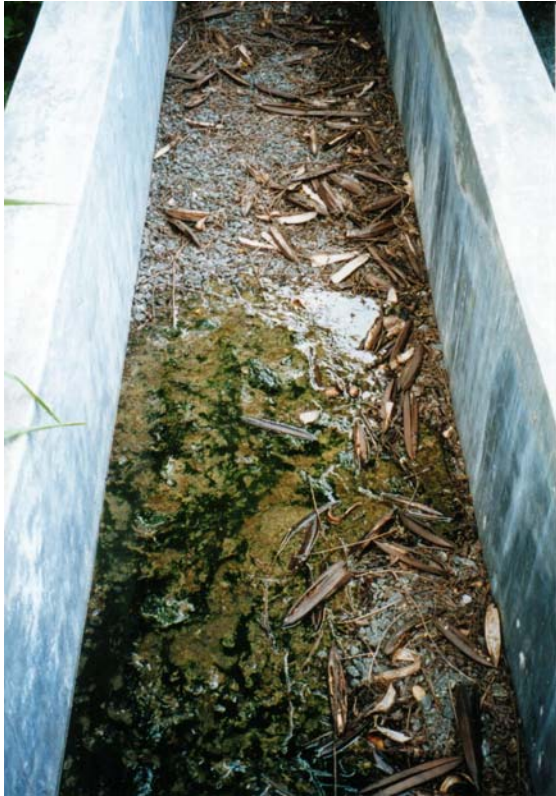
The unvegetated beds, though, produced a reasonably good quality effluent. However, with time, a biomat was observed to form on the surface of the bed at the inlet end, which caused local clogging in that area of the bed. This biomat steadily progressed down the bed, until the entire bed was covered and completely clogged. Plate 4-5 shows a view of an unvegetated channel with partial clogging of the bed. The biomat is visible on the surface of the bed in the lower half of the picture. Plate 4-6 shows a view of a reed bed channel, which had become completely clogged over its entire length. Water was stagnant over the bed surface and was highly active with mosquito and other insect larvae. It was observed that this clogging was a surface phenomenon, and the stagnant water could be released by prodding the surface of the bed with a stick. Plate 4-7 shows a view of the surface biomat after the water had been released in this manner.

Plate 4-5. An unvegetated reed bed channel with inlet zone clogging.

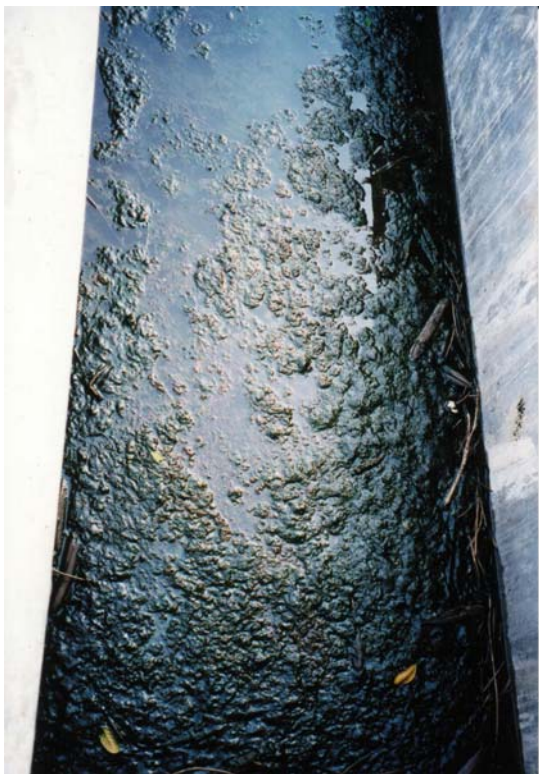
Plate 4-6. A completely clogged reed bed channel.

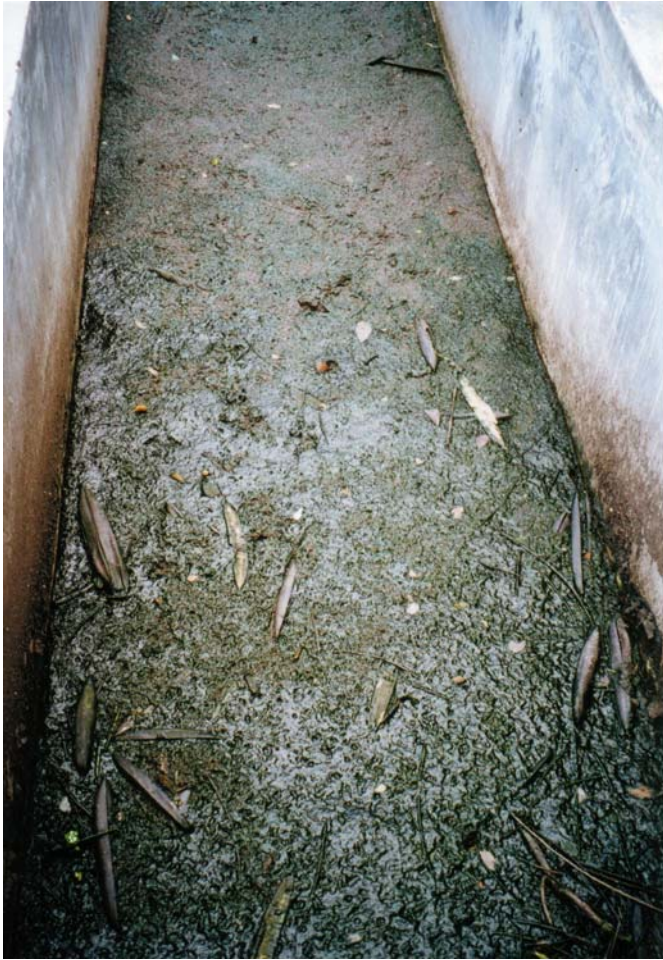
Plate 4-7. The biomat layer soon after releasing the stagnant water.

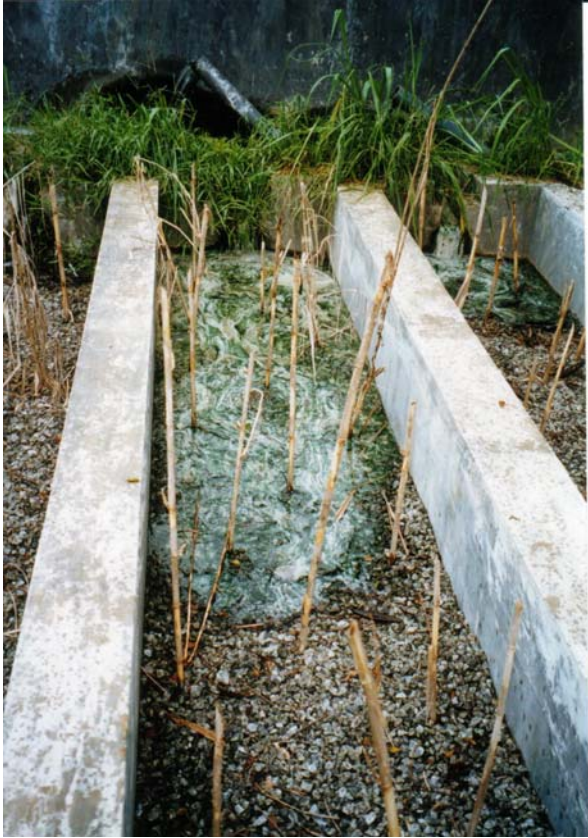
Eventually, out of desperation, the beds were vegetated on a voluntary basis, by some of the students and the two inner channels brought into proper operational condition. The vegetation was established by cutting stems of common reeds from nearby reed stands, and sticking them into the bed at approximately 30 - 60 cm intervals. The surface clogging was cleared by prodding the bed surface at regular intervals with a stick, but the biomat itself was allowed to remain. The reeds quickly established themselves within a couple of weeks and the biomat gradually disappeared completely, with the establishment of the vegetation. Plate 4-8 shows the planted reed stems in the bed a couple of days after planting. The biomat is visible in the upper part of the channel. Plate 4-9 shows a close up view of the bed with the vegetation fully established and the biomat completely cleared. This condition prevailed as long as the beds remained vegetated.

Plate 4-8. The reed stems a couple of days after planting

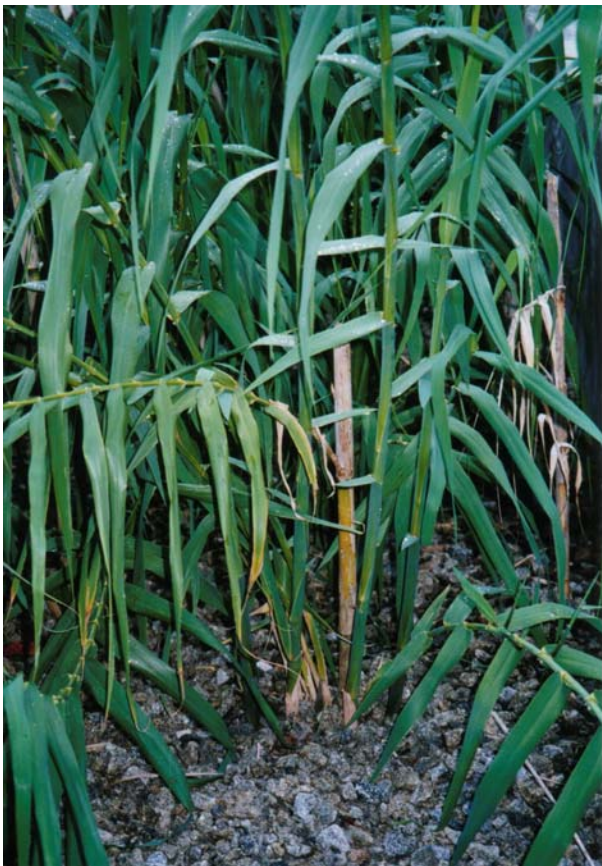
Plate 4-9. A close up view of the fully vegetated bed with no sign of biomat formation.

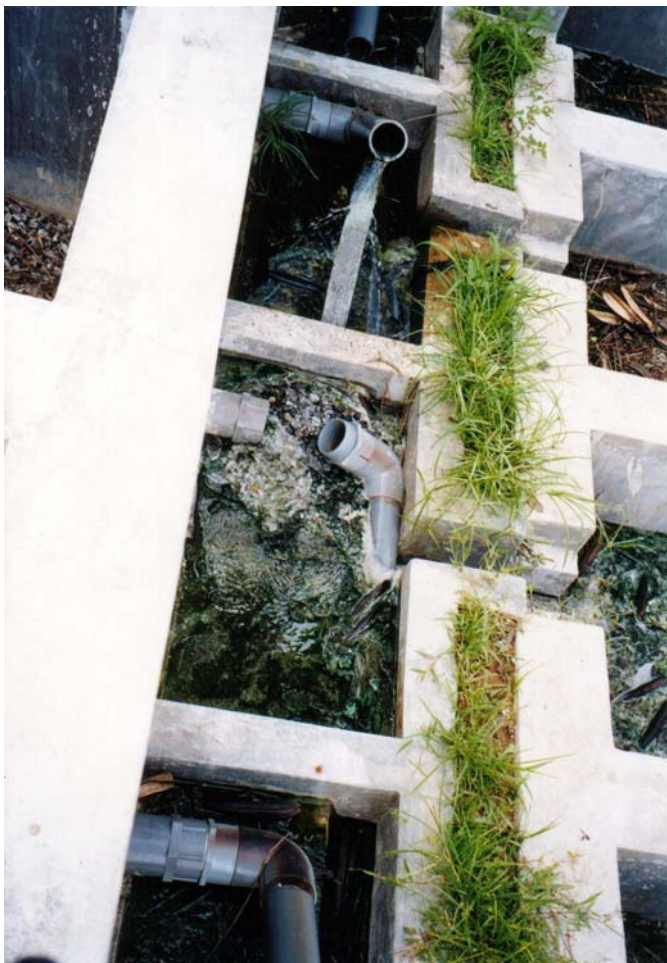
The present condition of the system is that passers by have completely shut down the system once more, due to the inconvenience caused to them by the waterlogging of the road due to the leaks in the beds. As a result, the beds have become, for all intents and purposes, abandoned, with untreated effluent overflowing from the distribution box and flowing overland to the stream nearby. Severe problems of odour and mosquitoes prevail in the vicinity due to the stagnant pools of effluent. Plate 4-10 shows an example of the poor state of repair of the system, with outlet flow control pipes broken and in a poor state of repair.

Plate 4-10. The effluent discharge elbows in a poor state of repair.

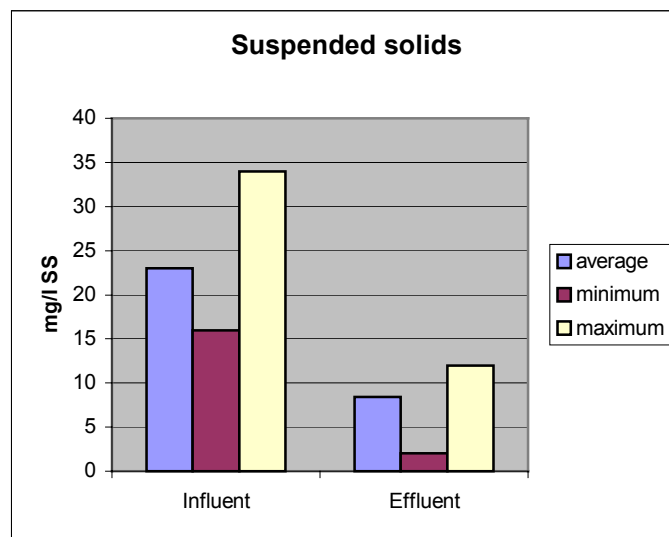
The suspended solids concentration in the influent to the filter was always low, with a mean value of 23 mg/l and a range of 16 to 34 mg/l. This was probably due to the large triple chamber septic tank, which preceded the filter. The effluent suspended solids concentration varied between 2 and 12 mg/l with a mean value of 8.4 mg/l. Figure 4-20 shows a graphical representation of these values.

Figure 4-20. Suspended solids concentrations for the Ladyhill anaerobic filter

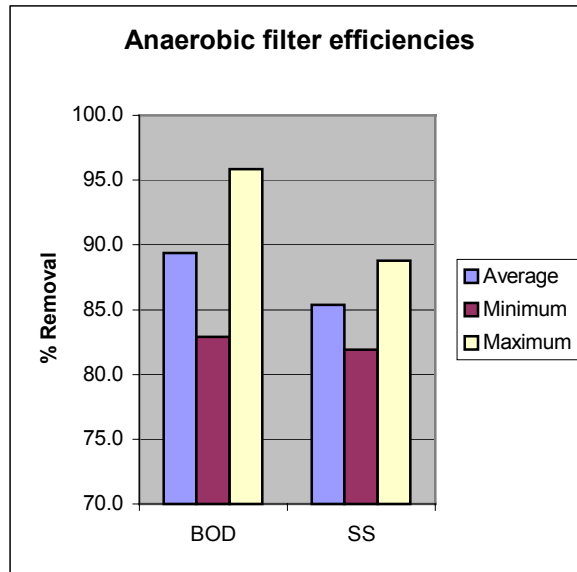
Figure 4-23. Removal efficiencies of the anaerobic filter unit

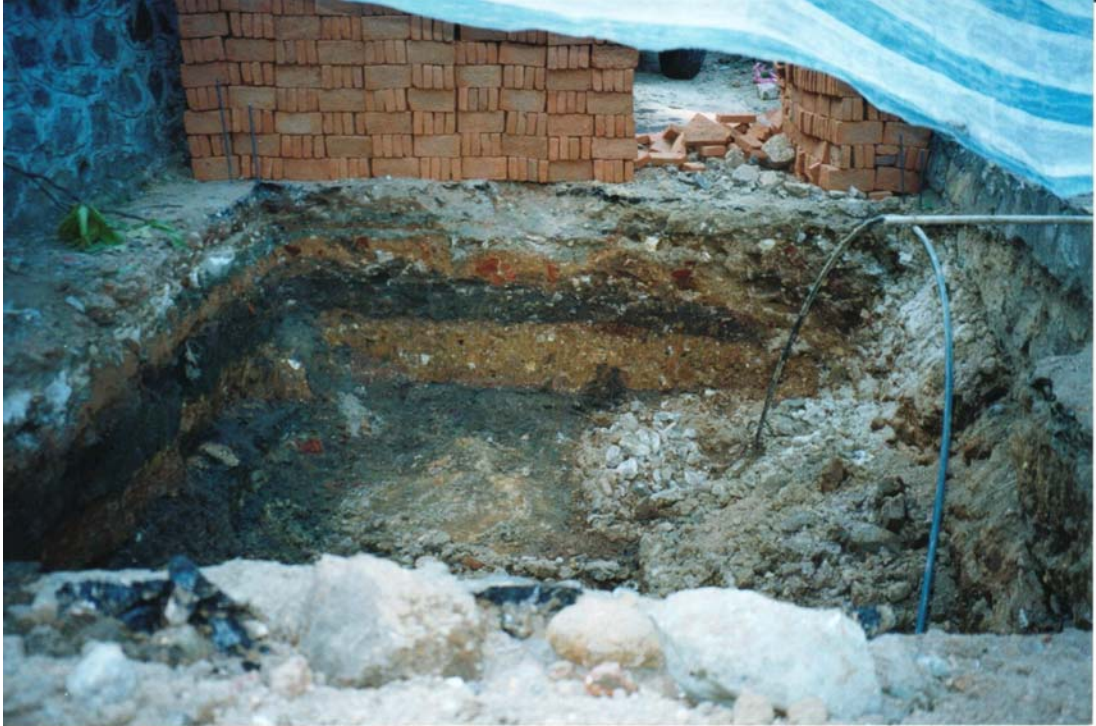
The Devon Rest system has been in operation for approximately one and a half years since September 1999. The maintenance activity has been limited to cleaning the grease trap of the kitchen wastewater line on a regular basis. This is a daily-cleaned grease trap. Some problems with odours from the septic tanks occurred due to improper sealing of the access manholes. The problem disappeared once the manhole covers were sealed. After a year and half of operation, the anaerobic filter started overflowing on one occasion. The cause was found to be an air block in the pipeline from the anaerobic filter to the percolation bed. Other than these occasional minor events, the system has been functioning well, with a high level of user satisfaction. The problem of the leaking of septage from the septic tank was discovered during excavation of the pit for the percolation bed unit. It was noticed at the time that black, foul smelling, water was seeping through a particular soil stratum intersected by the excavation. This problem stopped after repairing cracks in the lining of the septic tank. However, it appears to have recurred again, as the sampling results indicate. One reason is that the original septic tank had been built, resting on shallow bedrock, using the bedrock as its bottom without an additional base. However, the management of the hotel is reluctant to remedy the situation, as they see no benefit in doing it as the system is functioning to their satisfaction as well as that of the regulators. Plate 4-11 shows the excavation for the percolation bed with the black horizontal band of soil saturated with leaking septage visible in the centre of the cut on the left and far sides of the excavation. The leaking septic tank is behind the rubble masonry retaining wall visible on the upper left corner of the picture.

Plate 4-11. The excavation for the percolation bed intersecting the black soil layer.

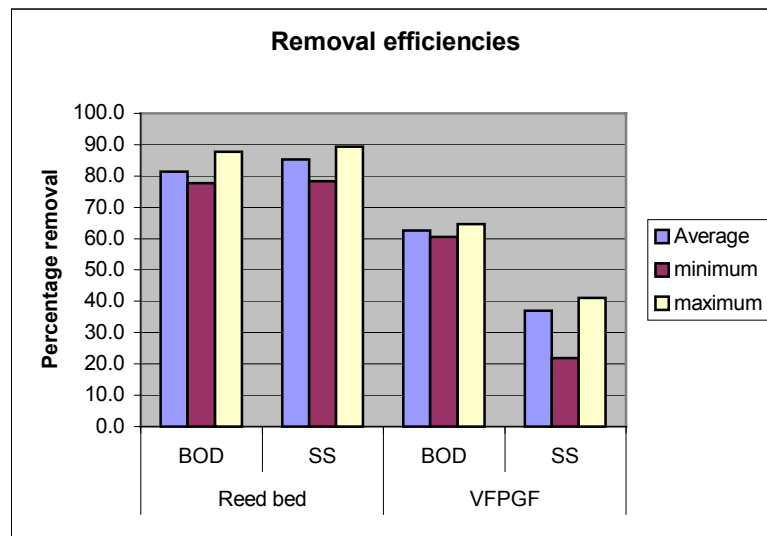
Figure 4-26. Removal efficiencies of the Kadugannawa treatment units

As can be seen in the figure, the removal efficiency for both BOD and suspended solids was around 80 percent for the reed bed. The actual values are a mean of 81.5 percent, and a range of 77.8 to 87.6 percent for BOD, and a mean value of 85.2 percent, with a range of 78.3 to 89.3 percent for suspended solids. The corresponding removal efficiencies were lower for the VFPGF unit, with a mean value of 62.5 percent, with a range of 60.6 to 64.6 percent for BOD removal, and a mean value of 37.1 percent, with a range of 22 to 41 percent for suspended solids removal. It should be noted here that the influent to the VFPGF unit was already of a very high quality in terms of both BOD and suspended solids, which would probably account for the lower removal efficiencies.

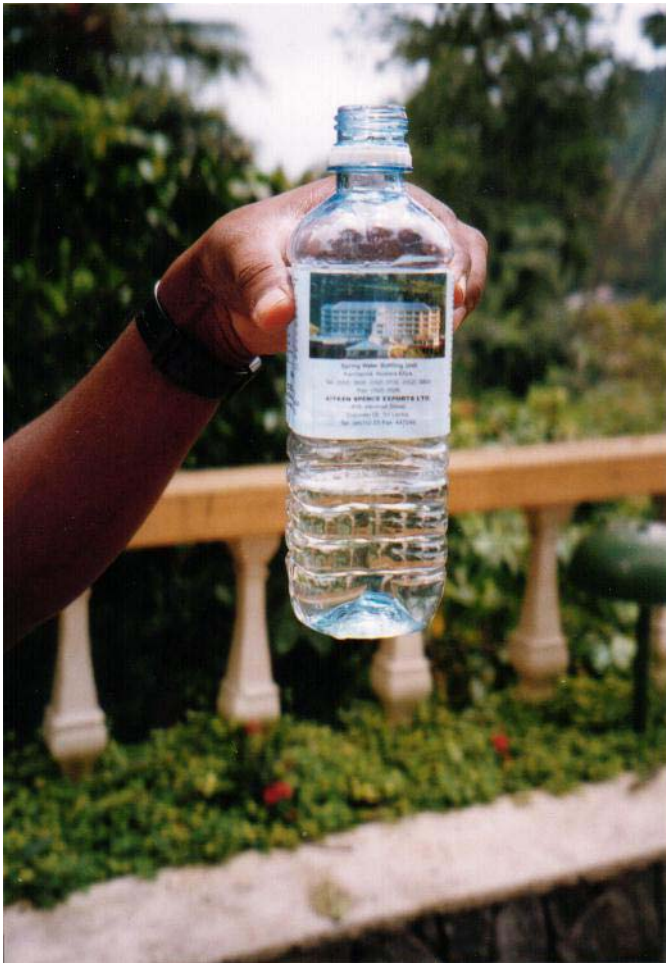
Plate 4-13. A typical effluent sample from the Thilanka treatment system.

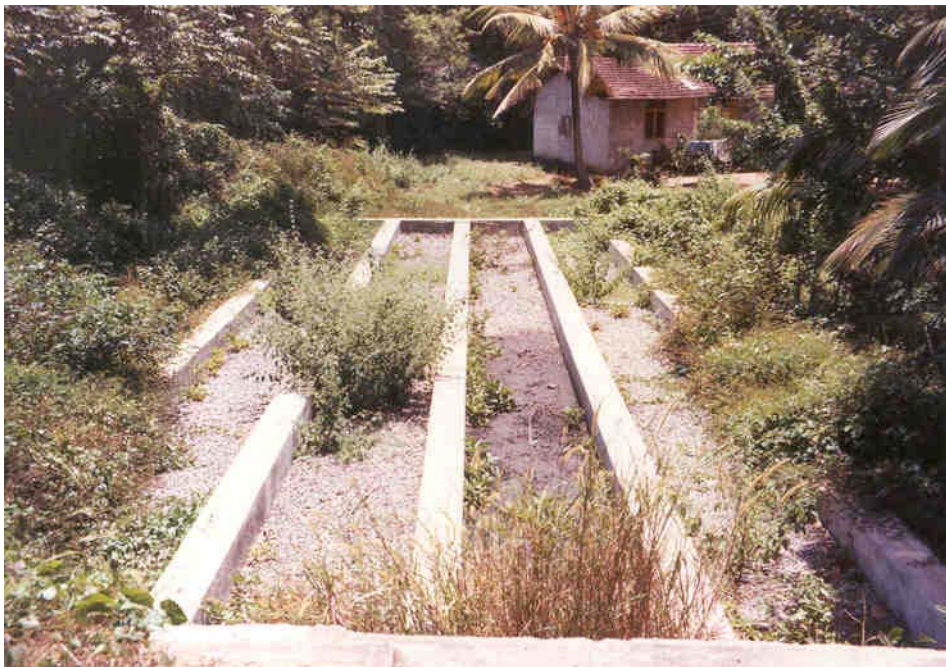
distribution channel to prevent invasion and clogging by external vegetation. The long-term maintenance of the system, though, as far as maintaining vegetation, is uncertain, judging by the level of maintenance activity of the local Pradeshiya Sabha. Plate 4-14 shows the condition of the reed bed system after the first eight months of operation. Most of the flow had been along the bottom of the third channel from the left, which was showing early signs of clogging as is evident from the surface flow visible on the near part of the channel.

Plate 4-14. The Ranpokunugama reed beds after eight months of operation

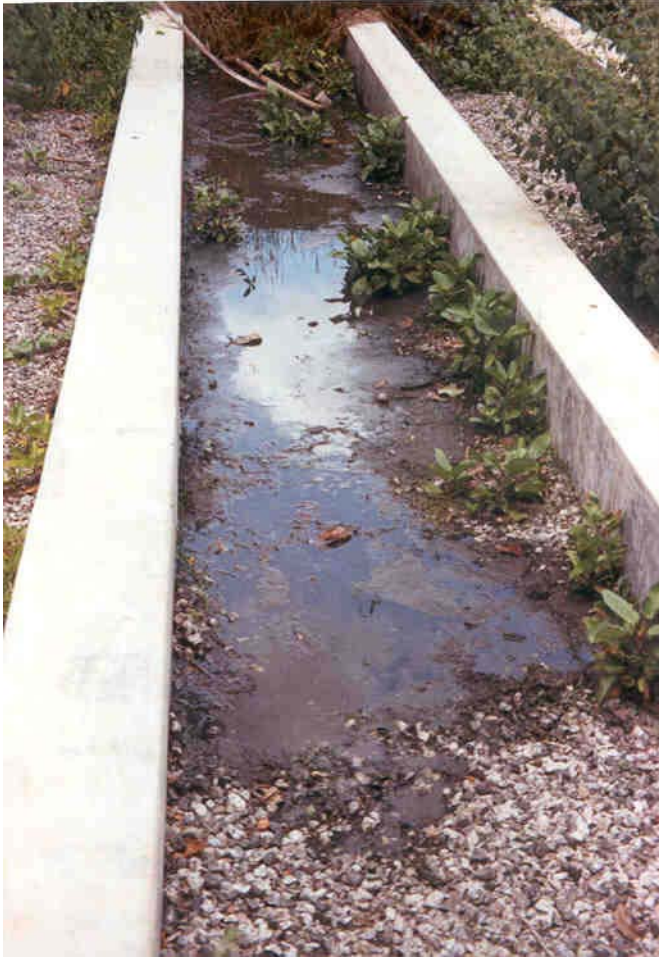
Plate 4-15. A close up view of the clogged area of the reed bed.

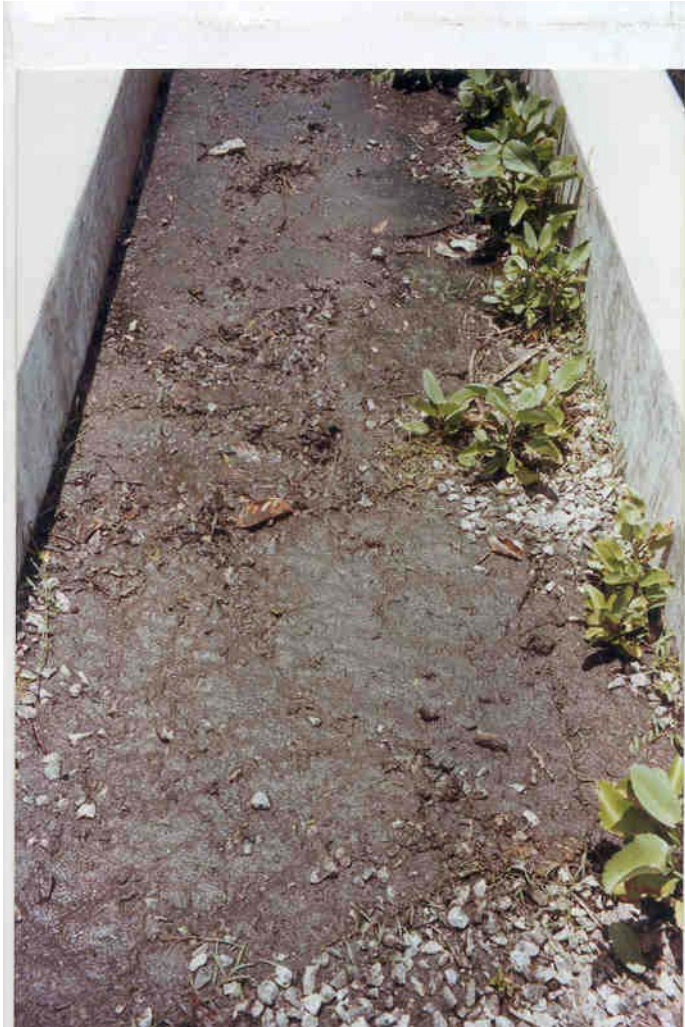
Plate 4-16. A view of the channel immediately after clearing the clogged area

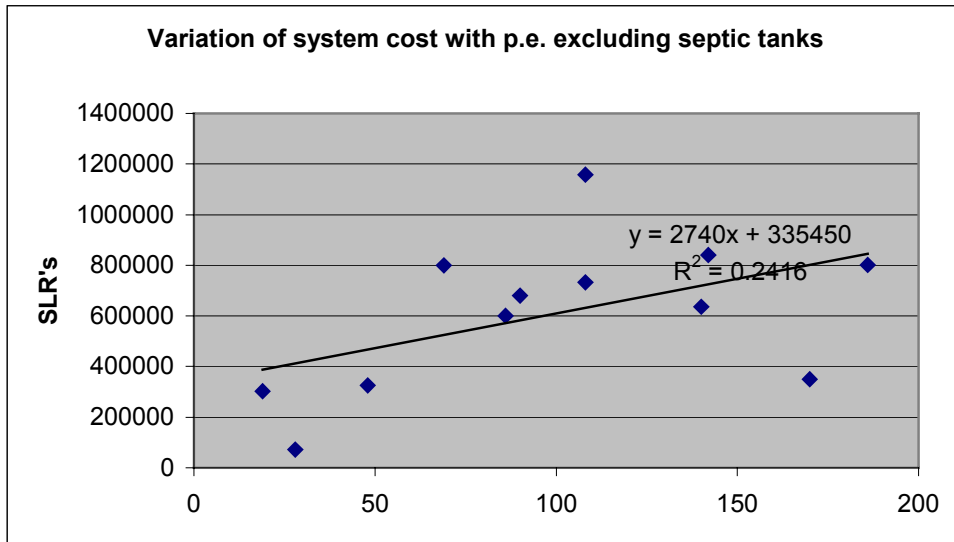
Figure 4-27. Plot of system cost vs. p.e. excluding septic tanks

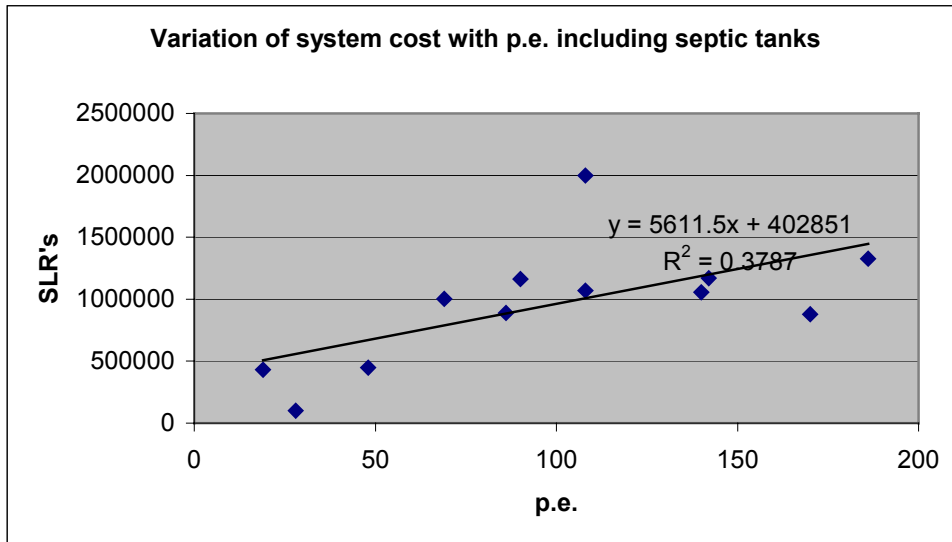
Figure 4-28. Plot of system cost vs. p.e. including septic tanks

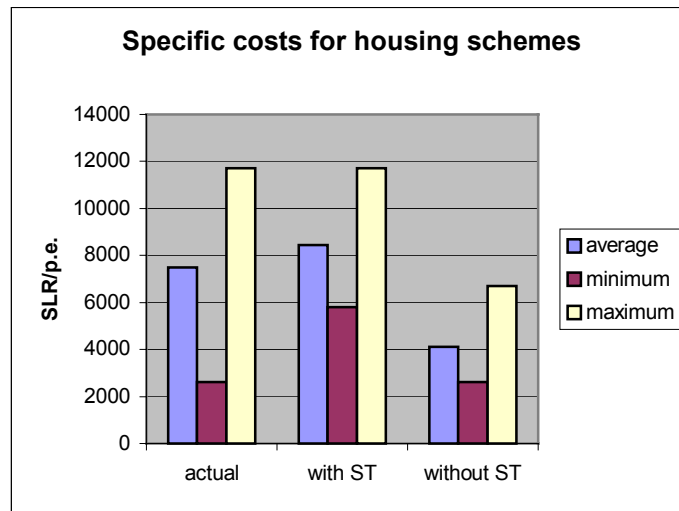
Figure 4-31. specific costs for housing schemes

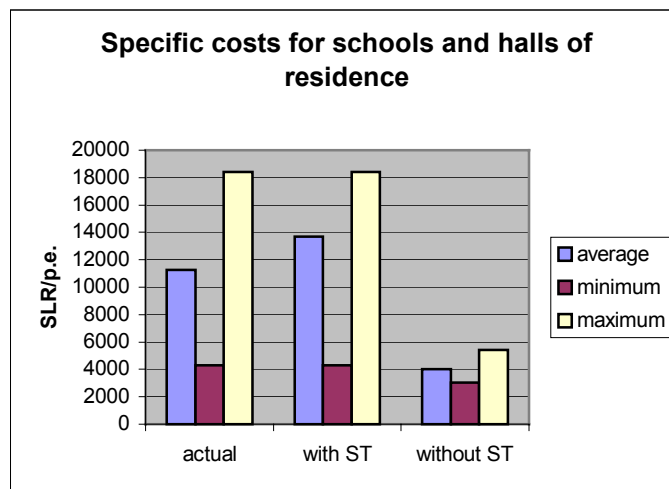
**Figure 4-32. Specific costs for schools and halls of residence**

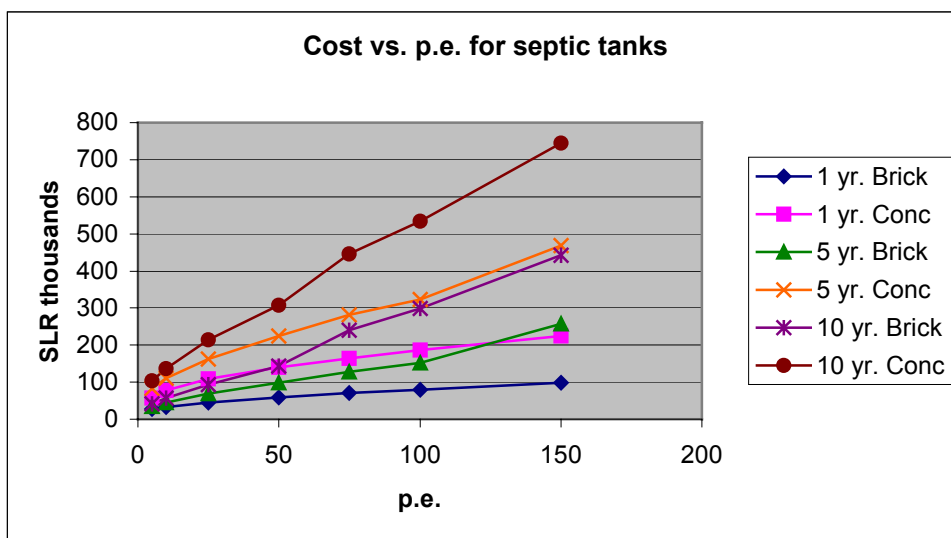
internal depth of 2.2 metres, which was typical in the real systems except when special site constraints such as shallow bedrock or very loose soil required shallower tanks. In the absence of such constraints, a depth of 2.2 metres was found to be an optimum compromise between cost and area occupied by the tank. The tanks were designed for optimum cost and efficiency, assuming that the space required for the particular geometry was available, without any special constraints. The results of this exercise are presented in Figure 4-34, which plots the cost of the tanks versus the p.e. for brick and concrete tanks separately for 1 year, 5 year and 10 year sludge storage periods.

Figure 4-34. Variation of cost with p.e. for different types of septic tanks

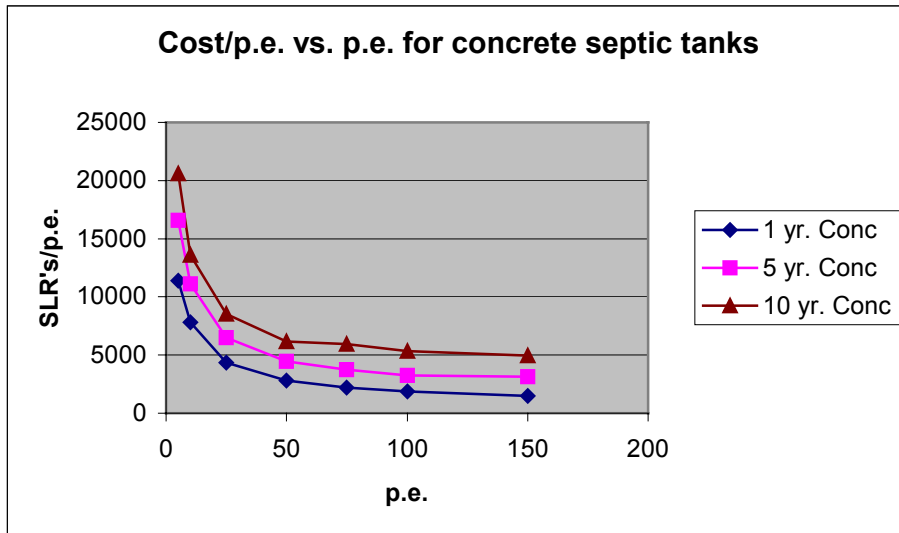
Figure 4-36. Variation of cost vs. p.e. for concrete septic tanks

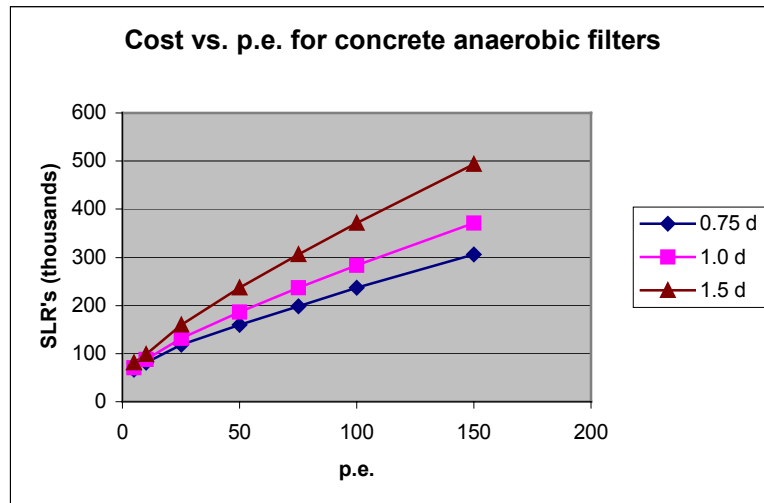
Figure 4-38. Variation of cost vs. p.e. for concrete anaerobic filters
