4. RESULTS AND DISCUSSION

4.2. The Swiss Residence, System 1

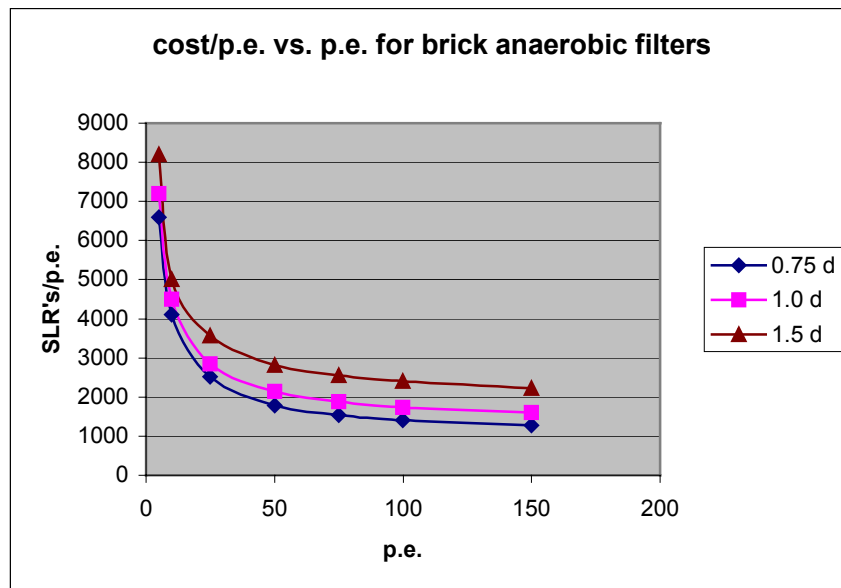
Figure 4-39. Variation of specific cost with p.e. for brick anaerobic filters

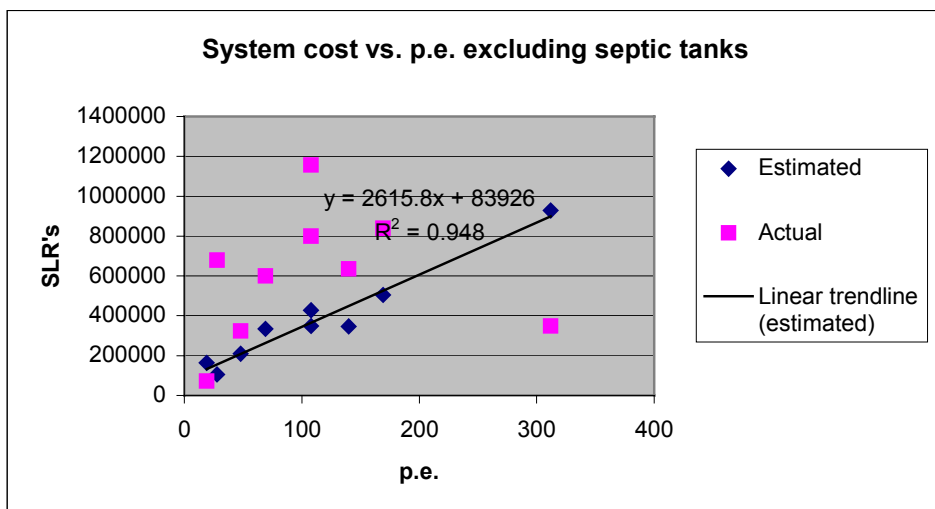
Figure 4-42. Plot of estimated and actual system cost vs. p.e. excluding septic tanks.
