# 10

## Rehabilitation and upgrading

### 10.1 REHABILITATION

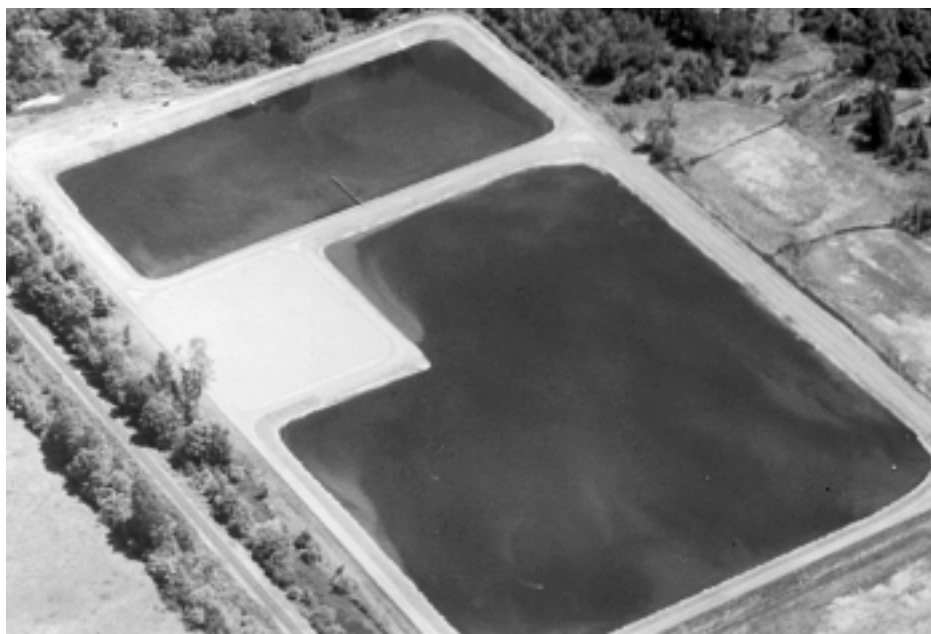
**Figure 10.2** Rock filter installed in the corner of a pond at Veneta, Oregon, USA

Rock filters consist of a submerged porous rock bed within which algae settle out as the effluent flows through. The algae decompose releasing nutrients which are utilized by bacteria growing on the surface of the rocks. In addition to algal removal, significant ammonia removal may also take place through the activity of nitrifying bacteria growing on the surface of the filter medium.

Performance depends on loading rate, temperature and rock size and shape. Permissible loading increases with temperature, but in general an application rate of 1.0 m<sup>3</sup> of pond effluent per m<sup>3</sup> rock bed per day should be used. Rock size is important, as surface area for microbial film formation increases with decreasing rock size but, if the rocks are too small, then problems can occur with clogging. Rock size is normally 75 – 100 mm, with a bed depth of 1.5-2.0 m. A typical rock filter is shown in Figure 10.2 (see also Figure 3.5). The effluent should be introduced just below the surface layer because odour problems are sometimes encountered with cyanobacterial films developing on wet surface rocks exposed to the light.

Construction costs are low and very little maintenance is required, although periodic cleaning to remove accumulated humus is necessary, but this can be carried out during the cooler months when algal concentrations are lowest. BOD and SS removals of 50 and 70 percent have been reported for maturation pond effluents in the USA (Middlebrooks, 1988).
